### Delamination vs Checking

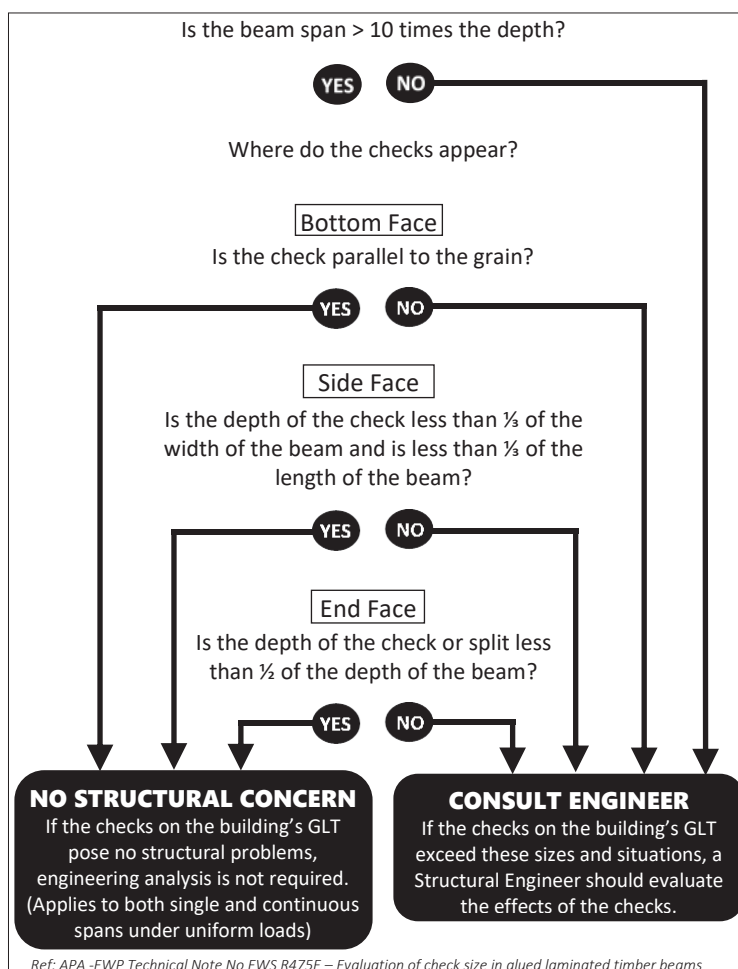
**Figure 1**  
**Is my GLT**  
**Beam ok?**

The APA – The Engineered Wood Association in North America has a long and extensive experience in the use of GLT, and has produced a “Rule of Thumb” flow chart for all the industry professional to analyse the beam and determine whether further engineering advice is needed to determine the structural adequacy of a GLT beam. See Fig 1.

This information is generic in nature as an initial assessment for uniformly loaded beams only, and does not replace expert engineering advice on a case by case basis.

If, after the use of the flow chart in figure 1 it is determined that the checking needs engineering evaluation, there are analysis methods available to the engineer to evaluate whether the reductions in strength caused by the checking is significant enough to warrant replacement or reinforcement.
