# WEATHERING

# ABOUT ACCOYA®

V08.15 – these guidelines have been written for professionals wishing to use Accoya to create beautiful, reliable and highly durable end products. Should you require further information or have any comments about this document, please contact Accsys through [www.accoya.com](http://www.accoya.com).

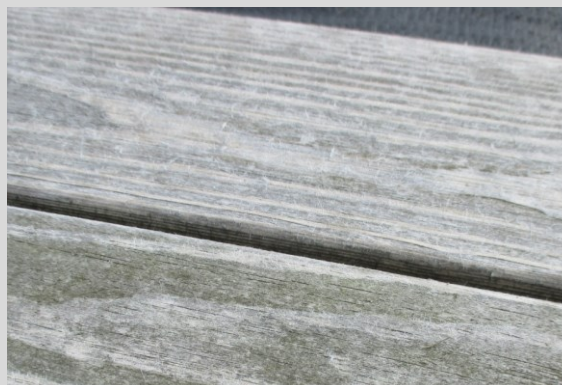
Natural occurring surface fibres on decking.

The higher the amount or intensity of UV the surface is subject to, the faster this process will develop. It should be noted that these fibres are formed on all exposed wood species, including Accoya, particularly on flat surfaces like decking. A ribbed deck profile will tend to cause an accumulation of these fibres, making it all the more noticeable.

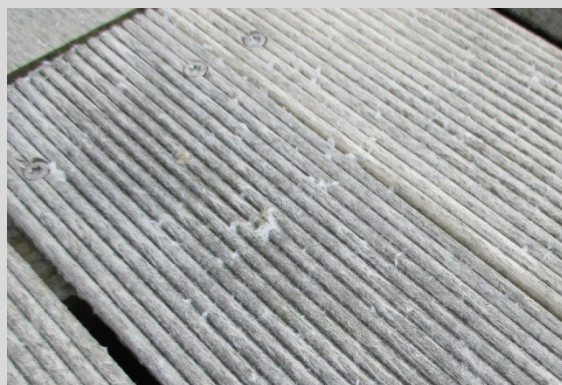
Fibres may get trapped in ribbed surface profiling.

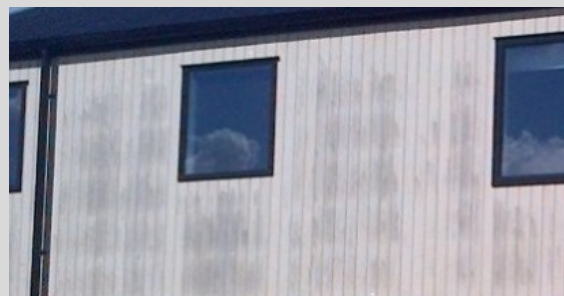
A New-Zealand housing project with a very distinct batten silhouette showing in the cladding surface.

Dryer conditions mean less mould growth, which is why the interfaces are clear where the rest of the board surface shows mould. Note that this effect can be observed on any façade with any kind of cladding or panelling material.

Some projects have shown a distinct pattern reflecting the sub-frame behind the Accoya. This is caused by heat transferal from the building to the Accoya boards, which will decrease the average moisture content at the location of the interface.

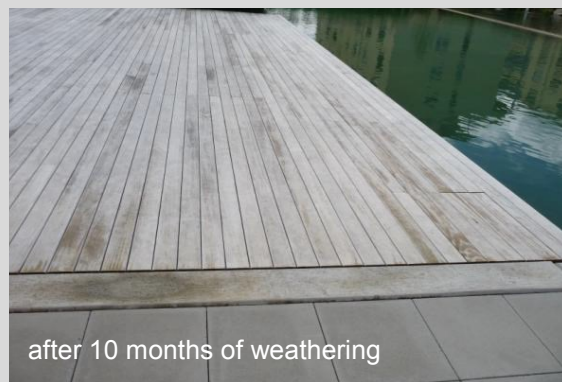
## PUBLIC POOL DECKING, OESINGEN, SWITZERLAND.

This deck in Oesingen was photographed when newly installed (left), after 10 months (middle) and after 30 months of weathering (right).

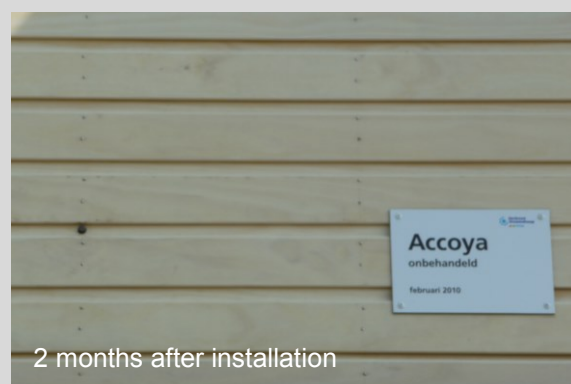
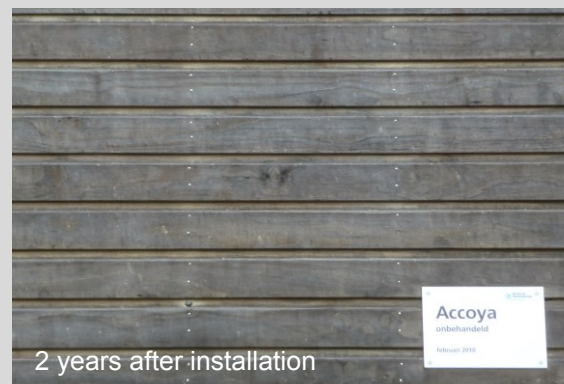
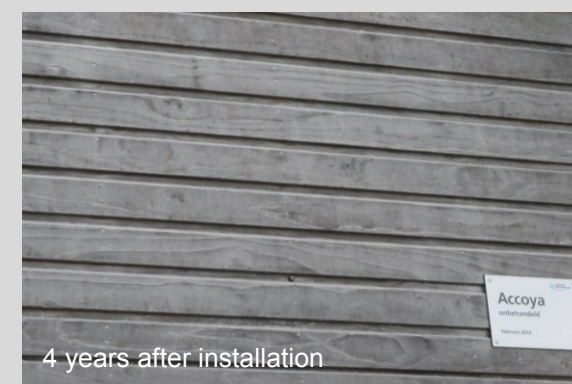
## OFFICE CLADDING, VROOMS- HOOP, THE NETHERLANDS

A part of the South facing façade was cladded with Accoya in April 2010, with no maintenance since. The pictures below (left to right) show this cladding in July 2010, 2012 and 2014.

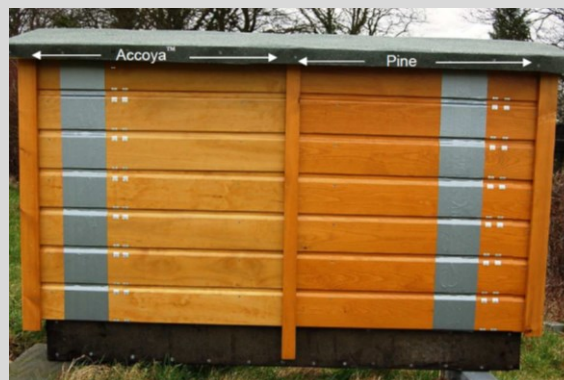
Test set-up at the start of the exposure in February 2008

A south-facing cladding rig was set up at BM Trada for the comparative performance evaluation of Accoya and unmodified pine coated with a semi-translucent stain.

The translucent stain system consisted of a pigmented primer with two topcoats. The cladding boards used were machined to a rebated shiplap profile with the upper edge rounded to a radius of  $\pm 10\text{mm}$ .
