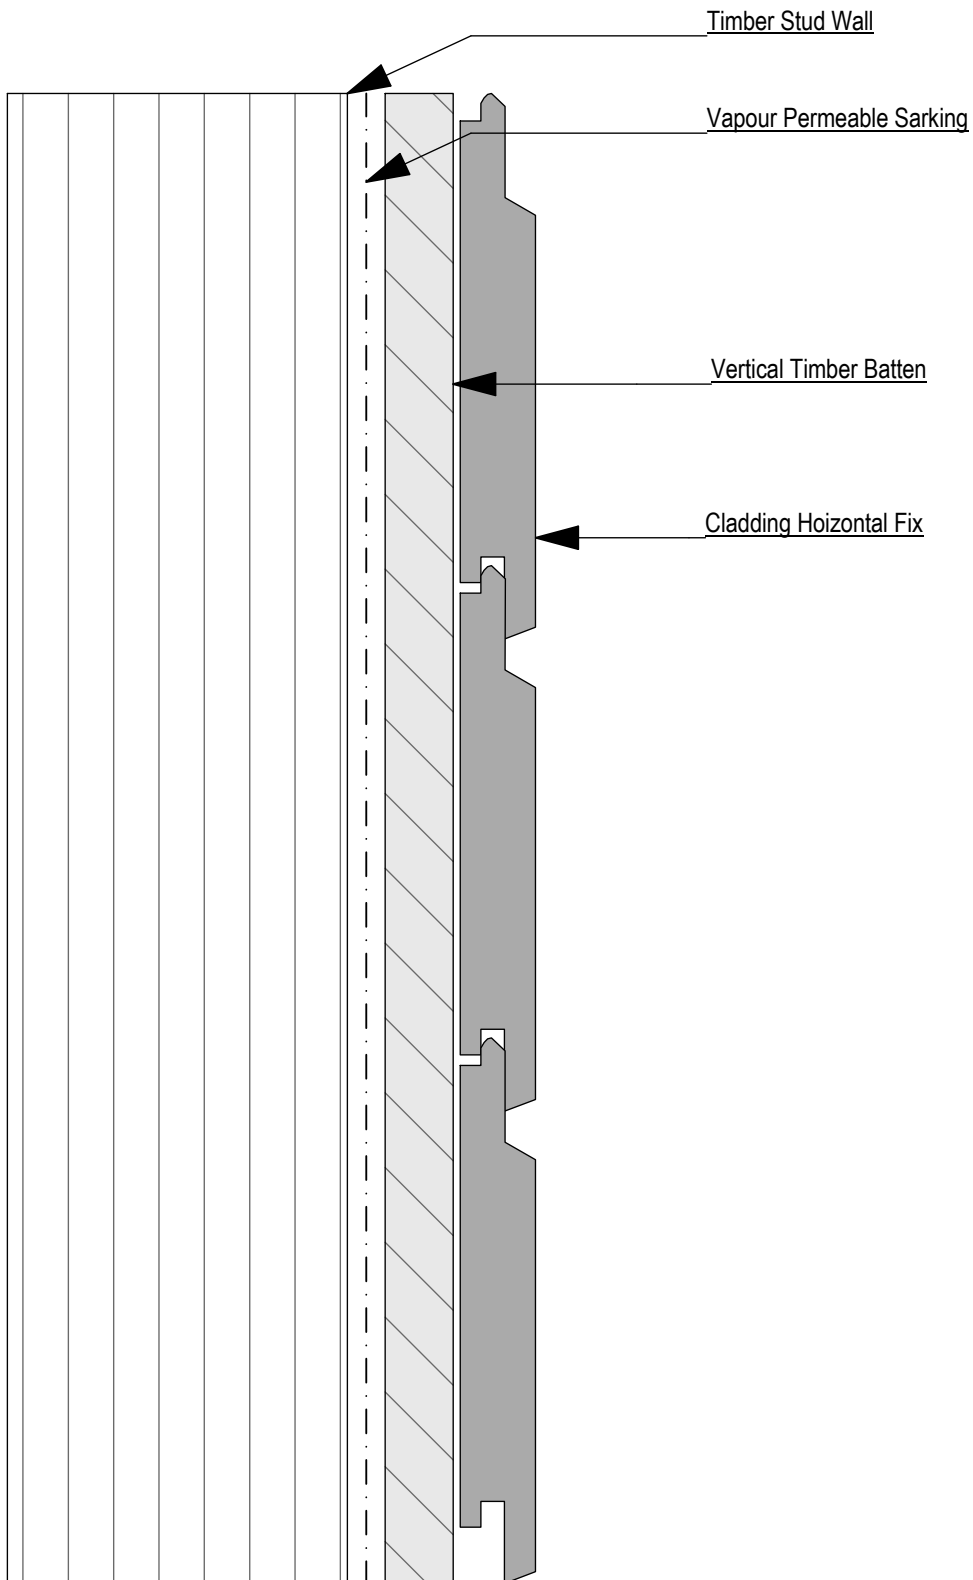
Dia 1: Horizontal Fix to Timber - Side View

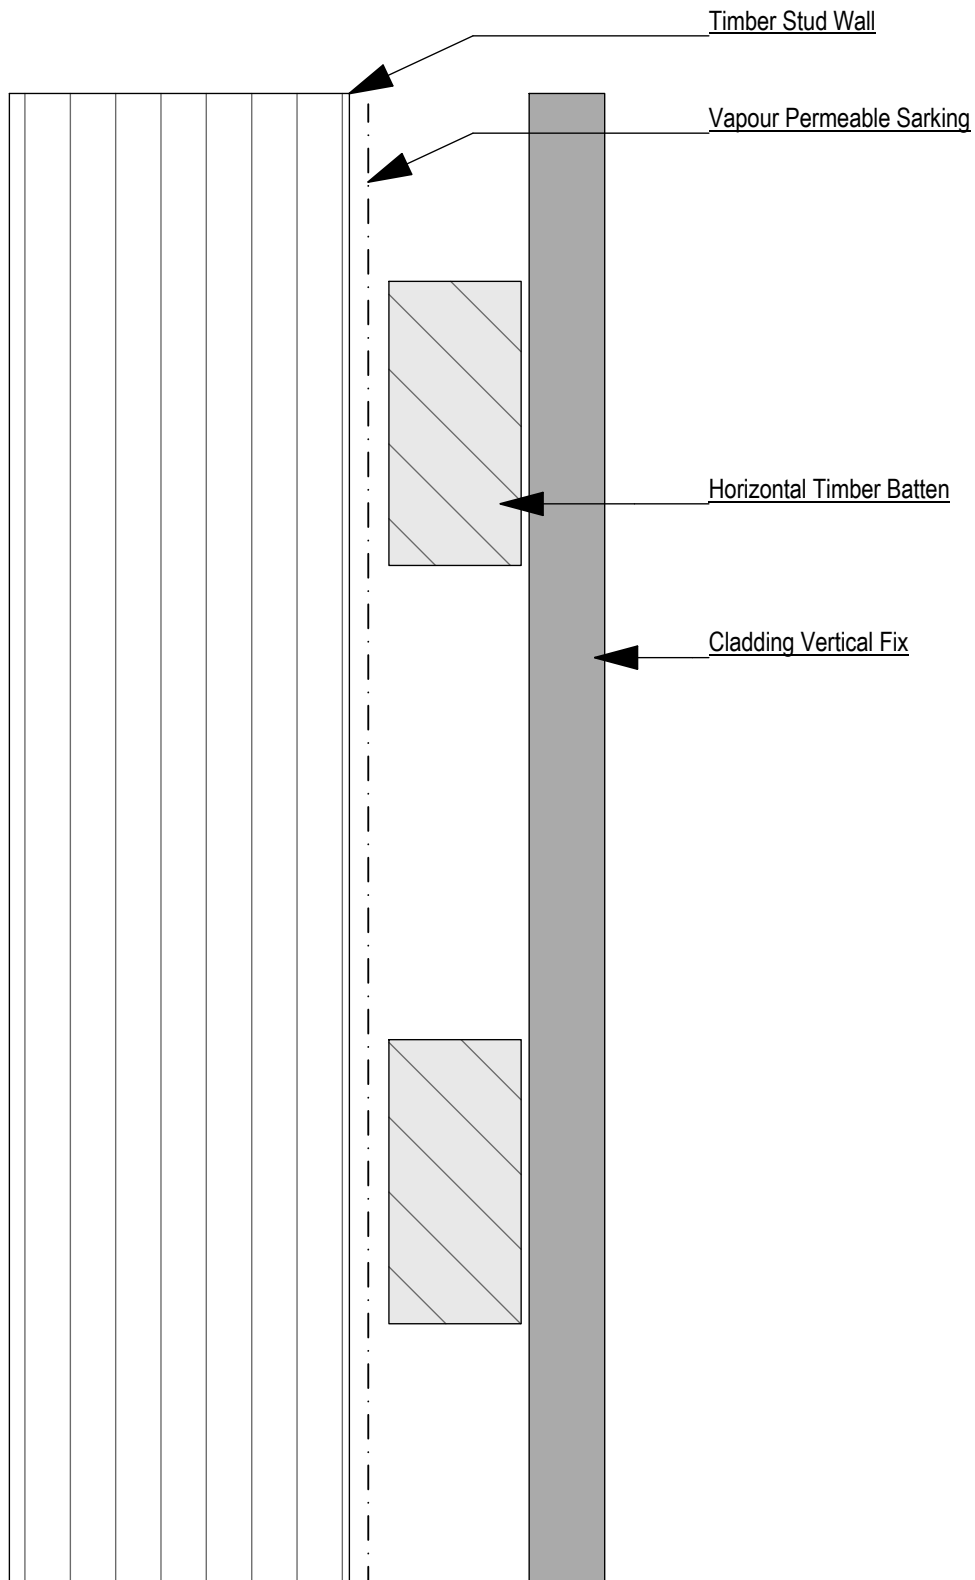
Dia 2: Vertical Fix to Timber - Side View

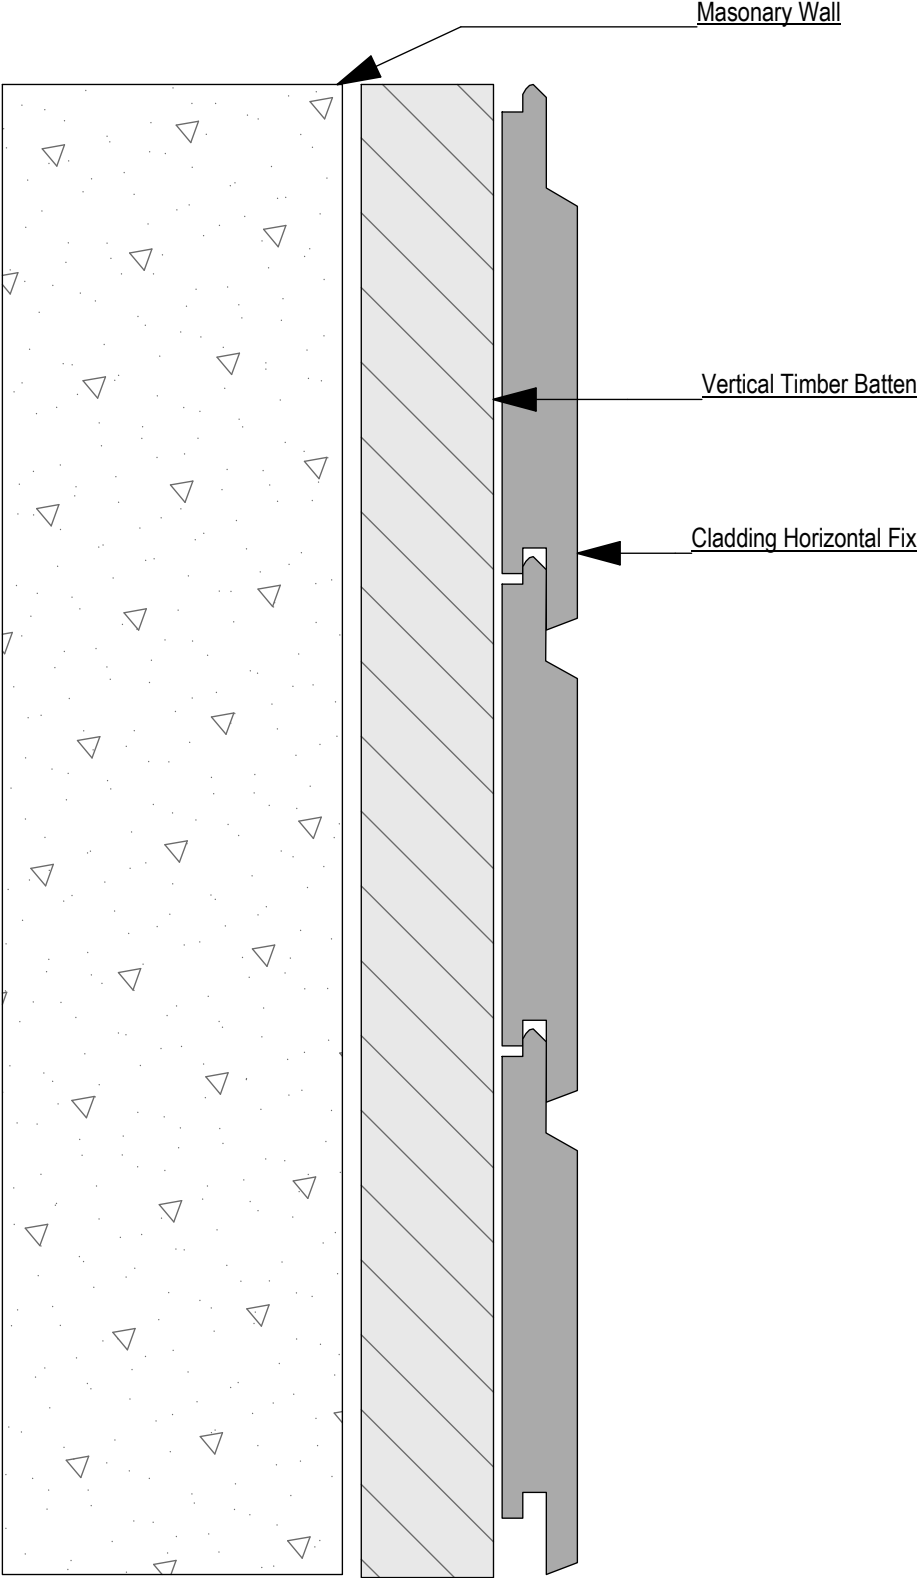
Dia 3: Horizontal Fix to Msonary - Side View

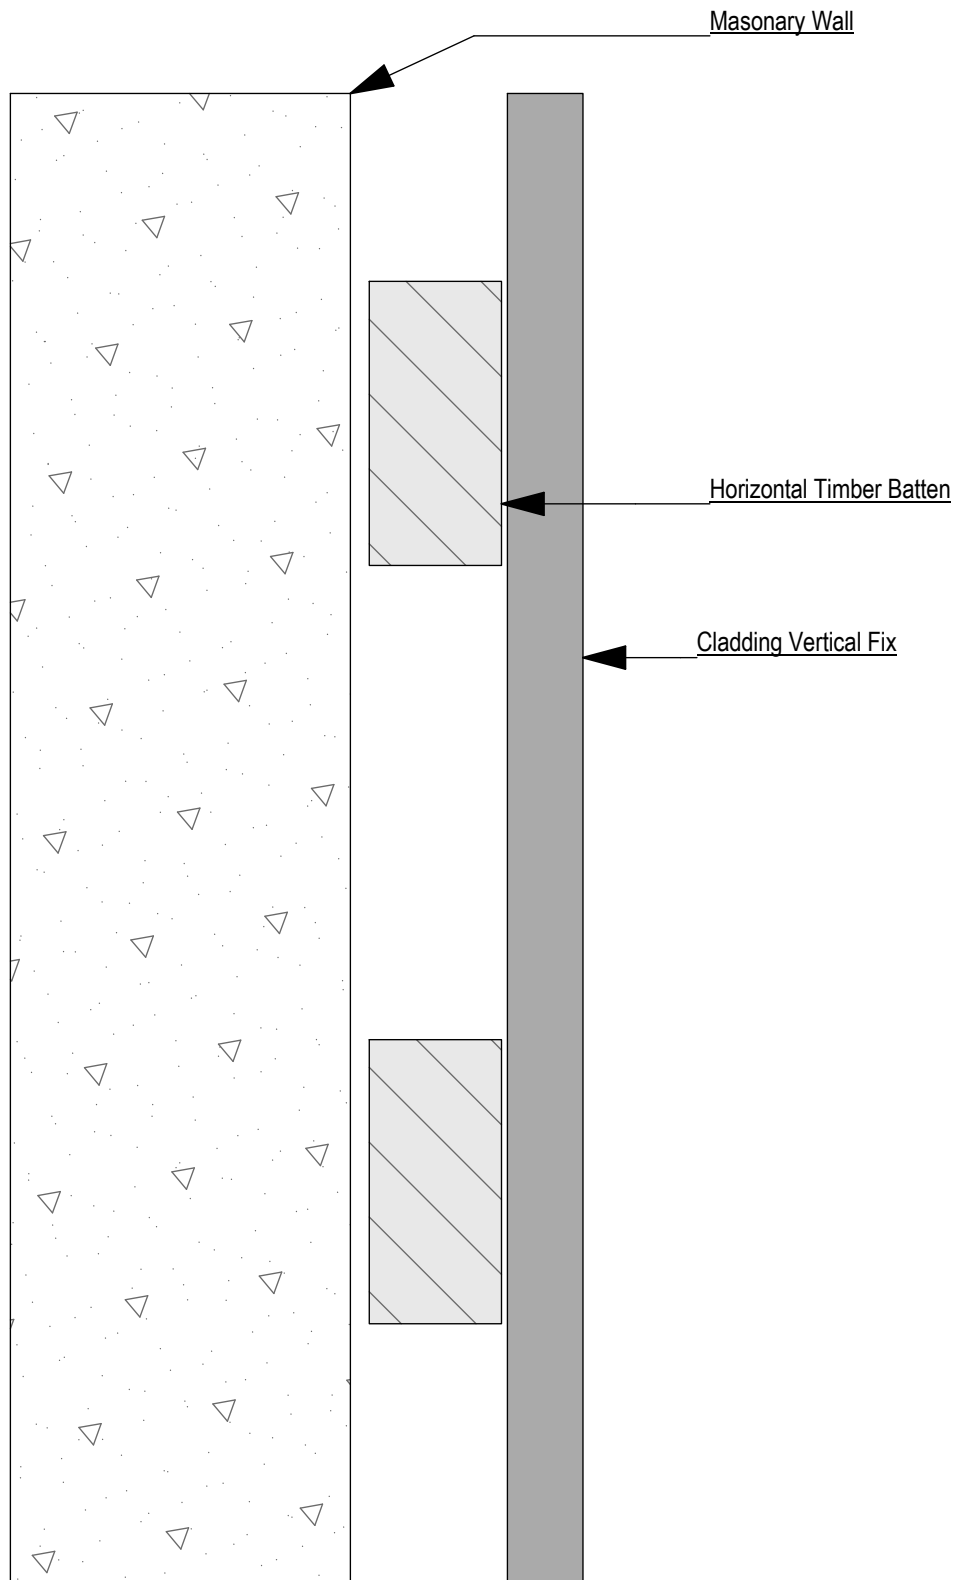
Dia 4: Vertical Fix to Masonry - Side View

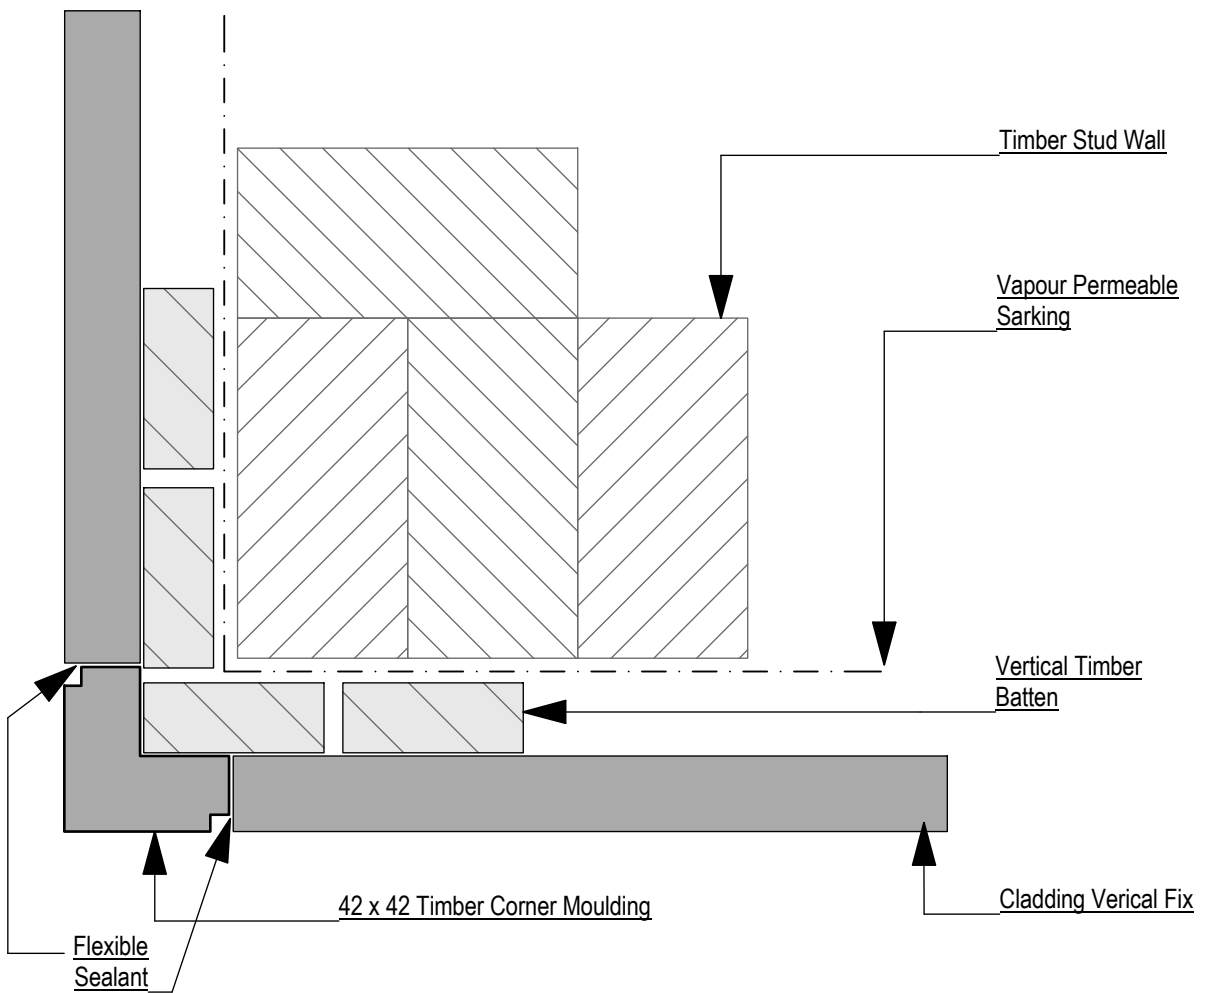
Dia 5: Horizontal Fix to Timber External Corner - with Timber Profile - Top View

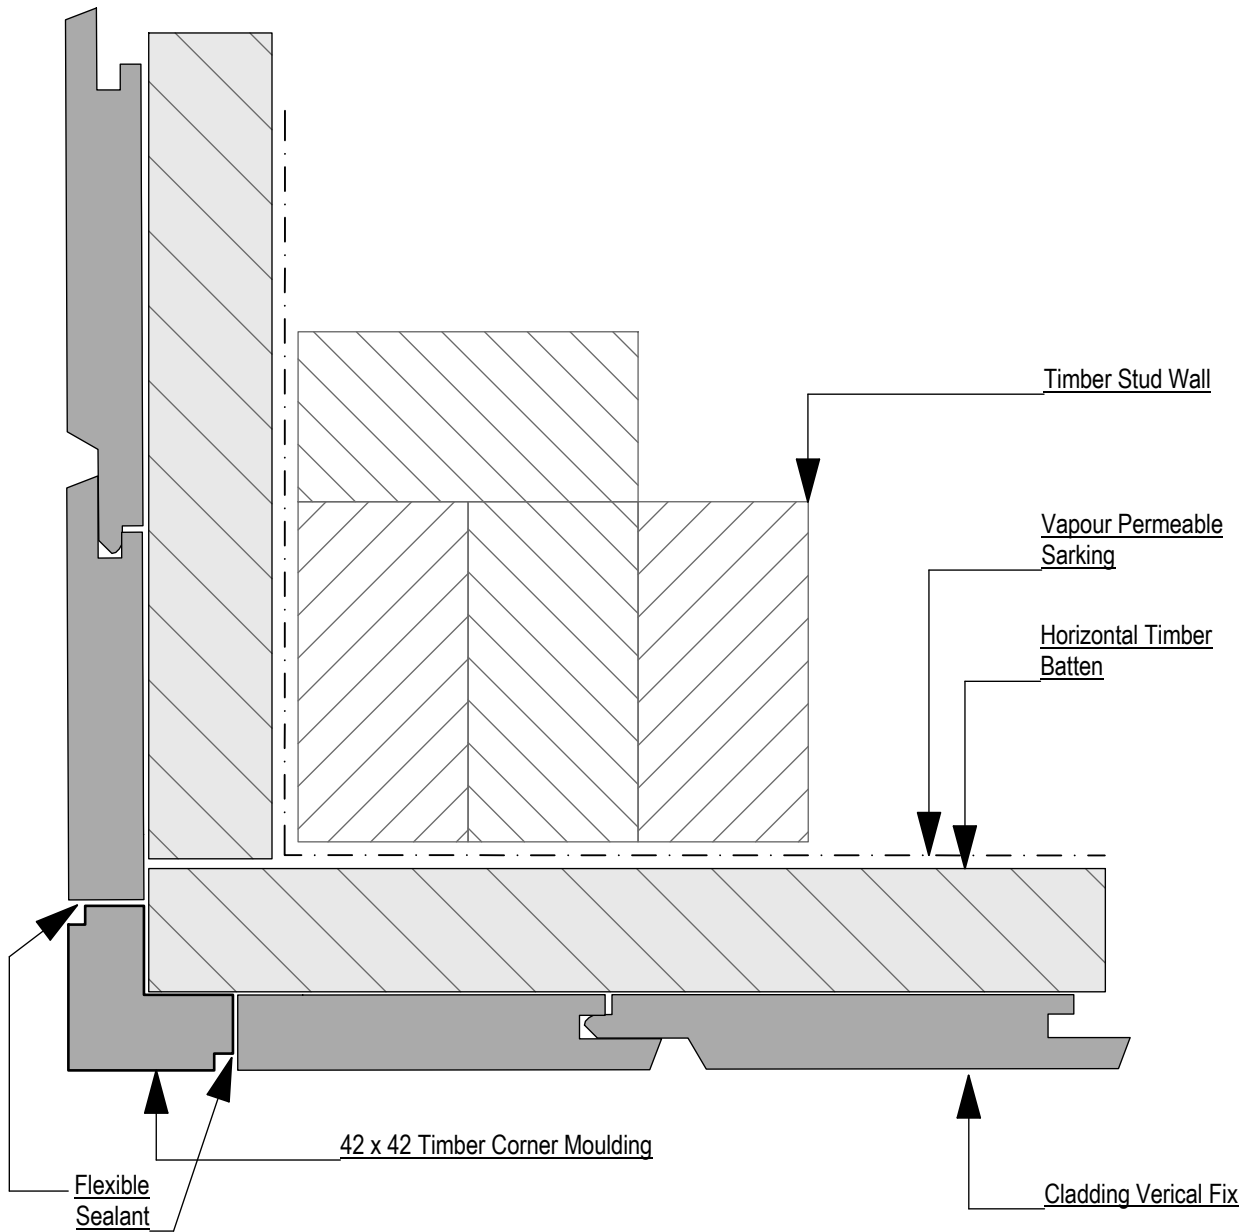
Dia 6: Vertical Fix to Timber External Corner - with Timber Profile - Top View

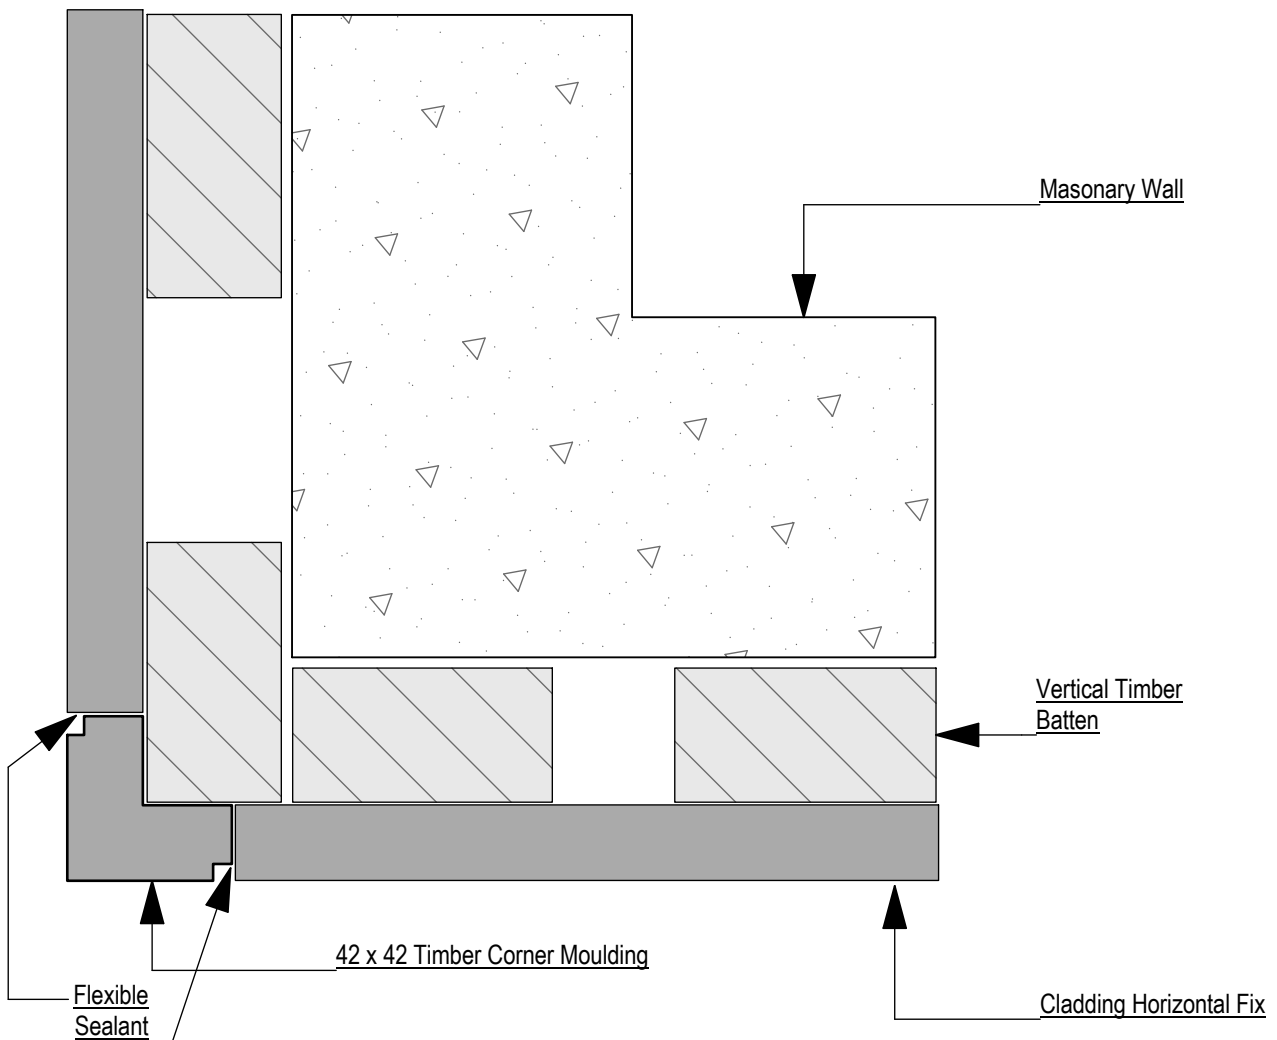
Dia 7: Horizontal Fix to Masonry External Corner - with Timber Profile - Top View

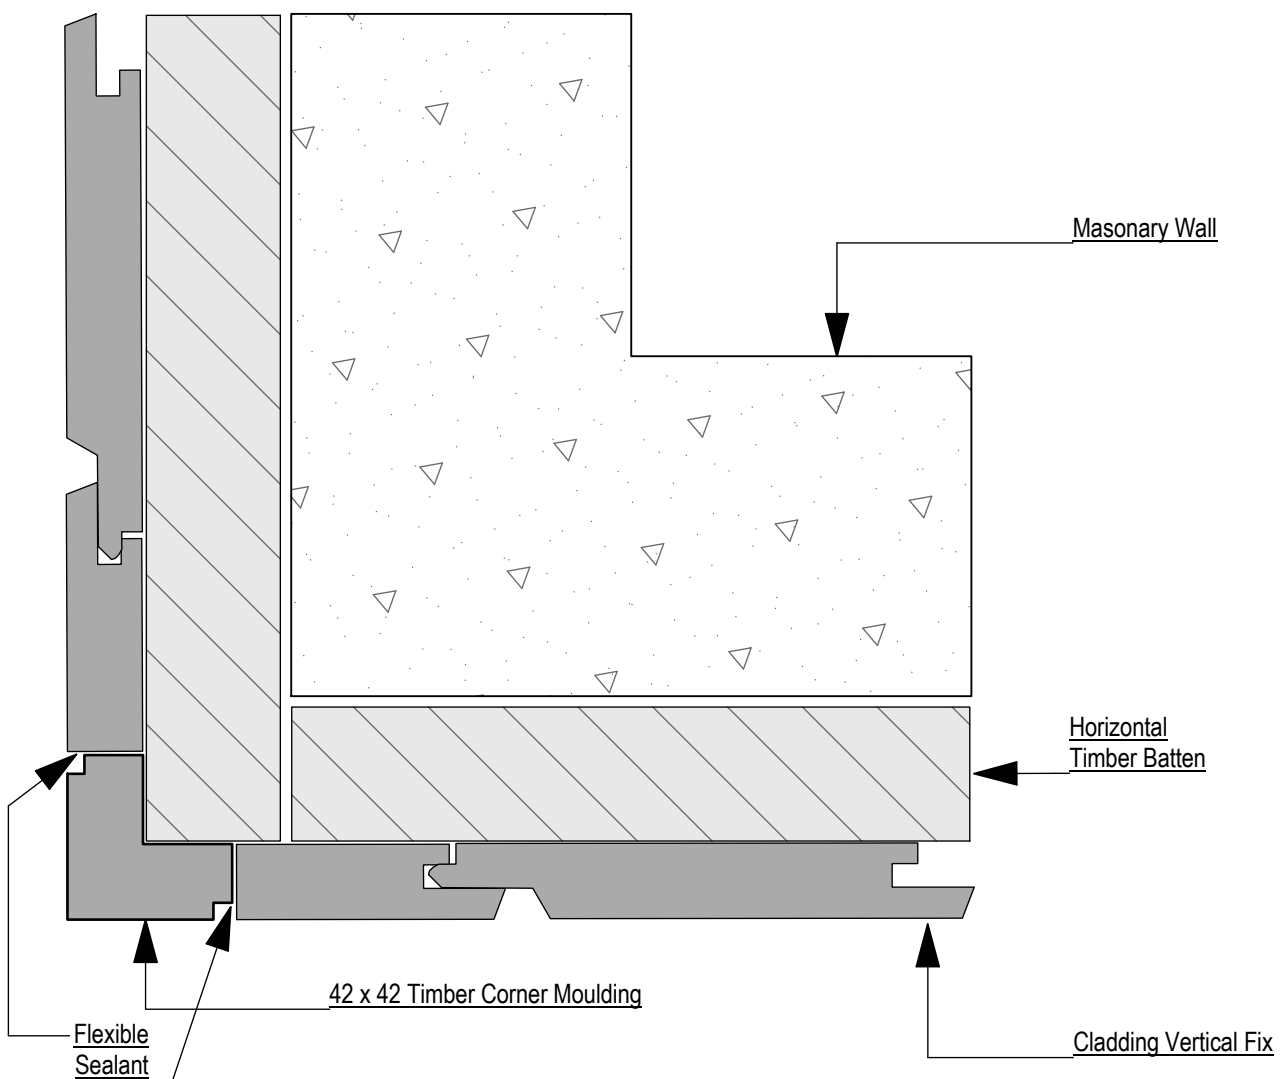
Dia 8: Vertical Fix to Masonry External Corner - with Timber Profile - Top View

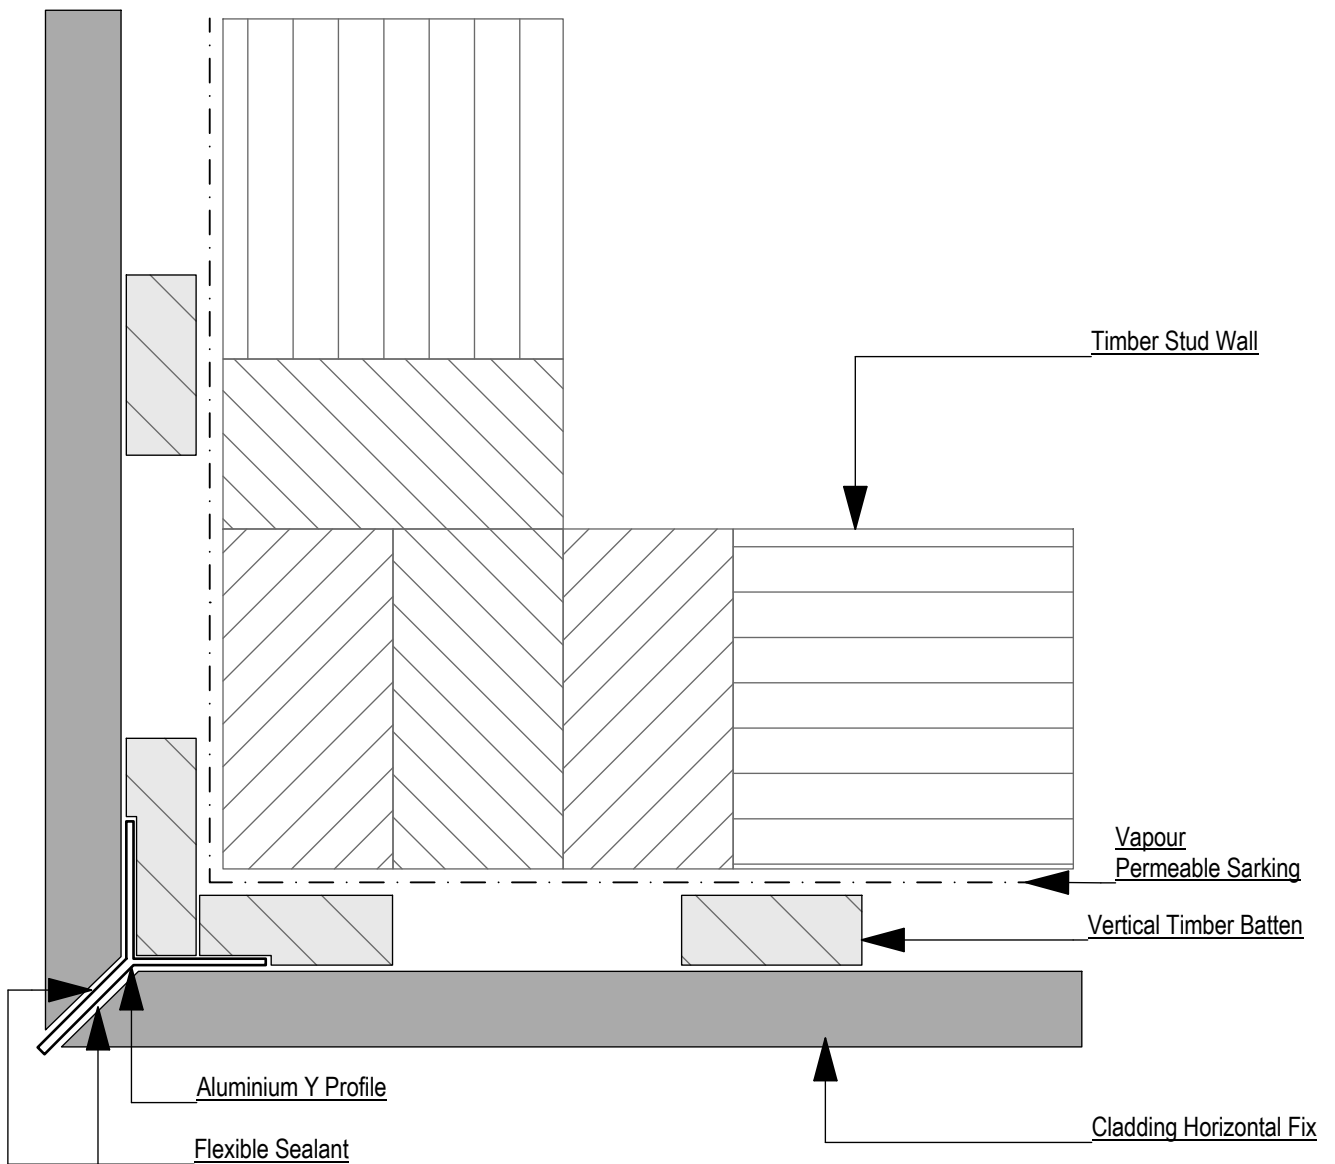
Dia 9: Horizontal Fix to Timber External Corner - with Aluminium Y Profile - Top View

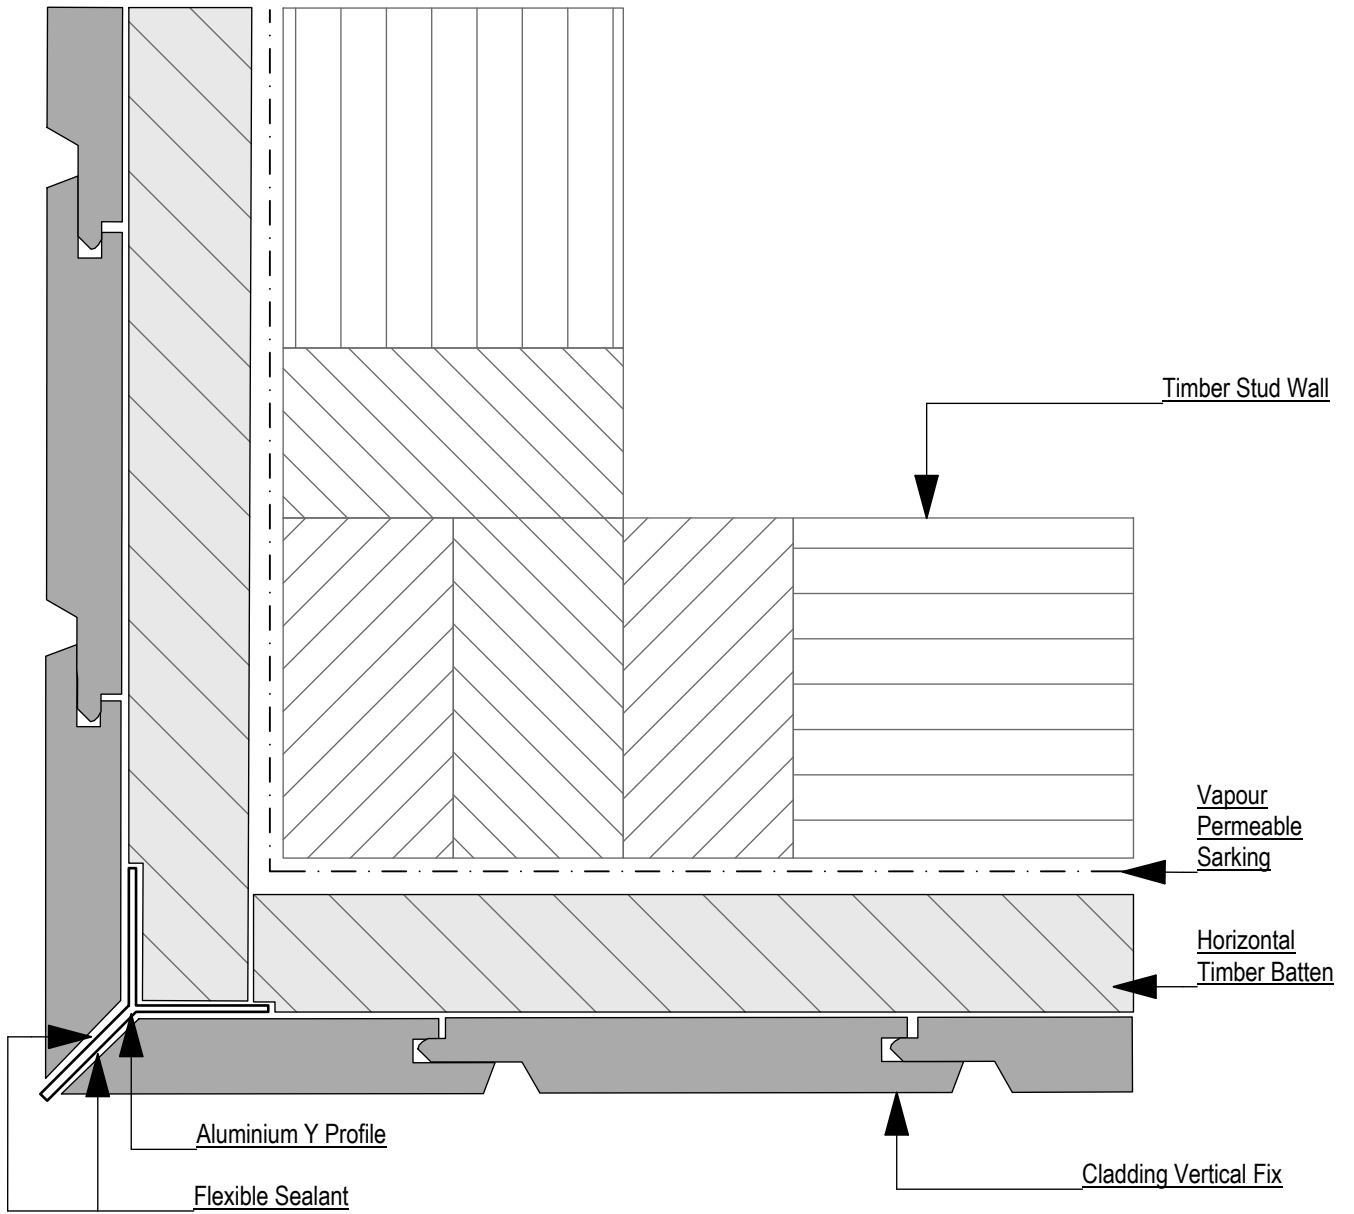
Dia 10: Vertical Fix to Timber External Corner - with Aluminium Y Profile - Top View

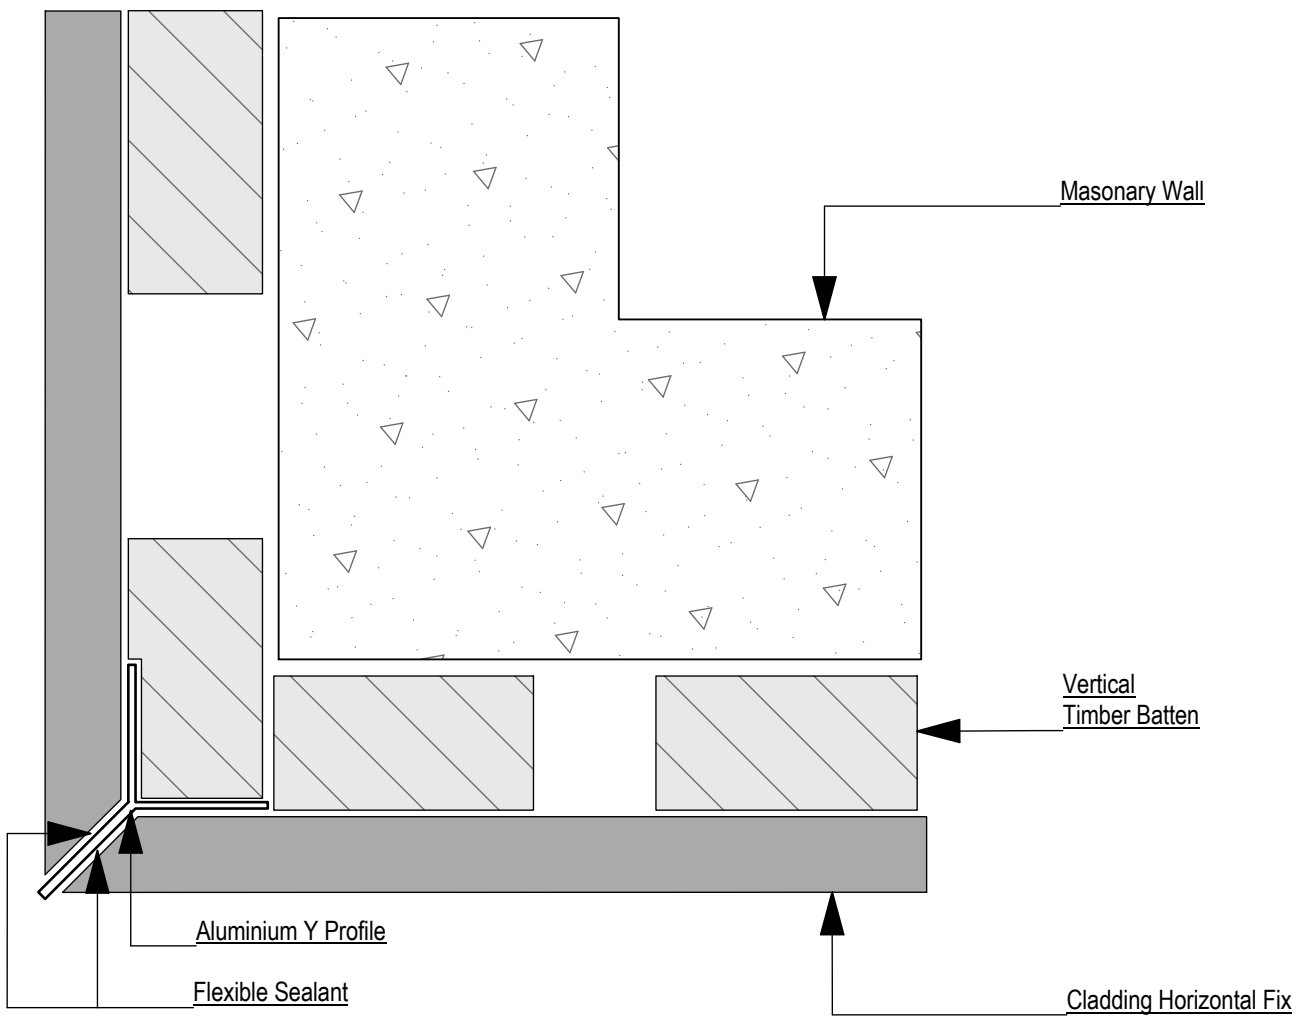
Dia 11: Horizontal Fix to Masonry External Corner
- with Aluminium Y Profile - Top View

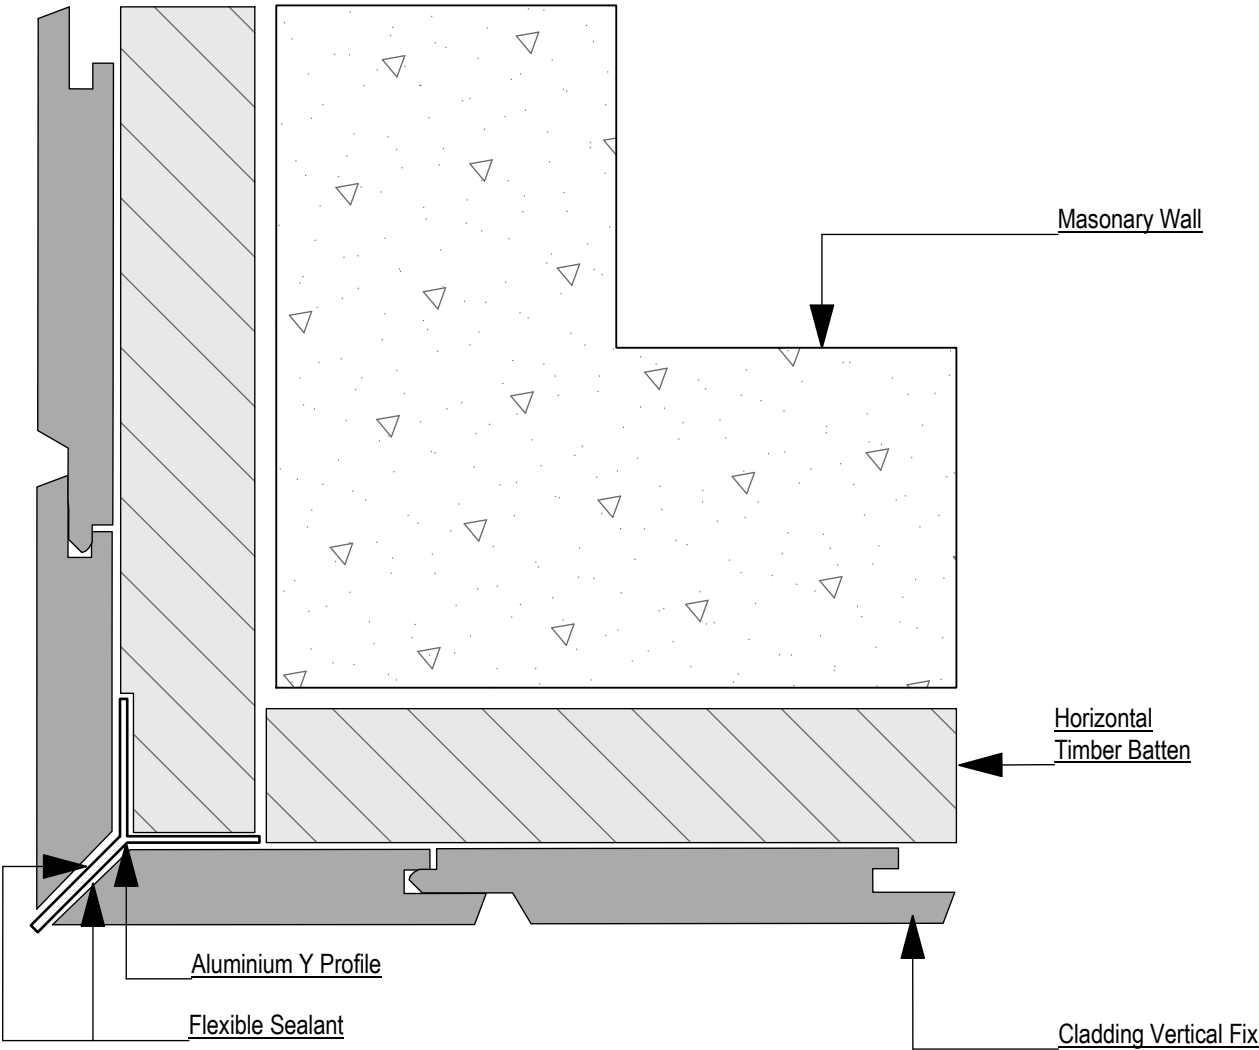
Dia 12: Vertical Fix to Masonry External Corner
- with Aluminium Y Profile - Top View

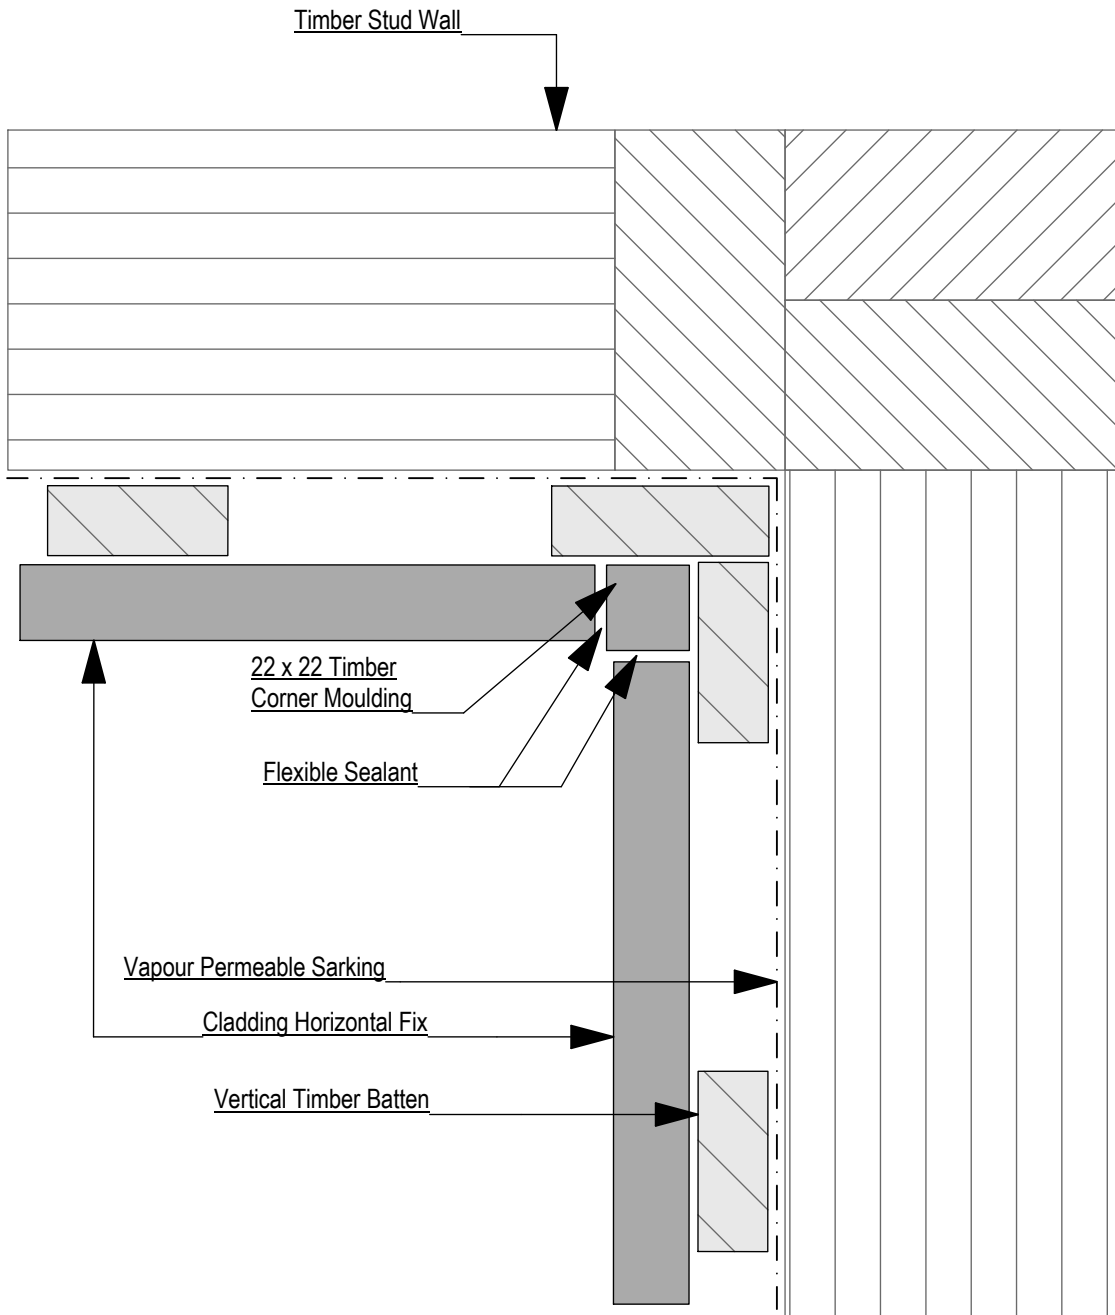
Dia 13: Horizontal Fix to Timber Internal Corner - with Timber Profile- Top View

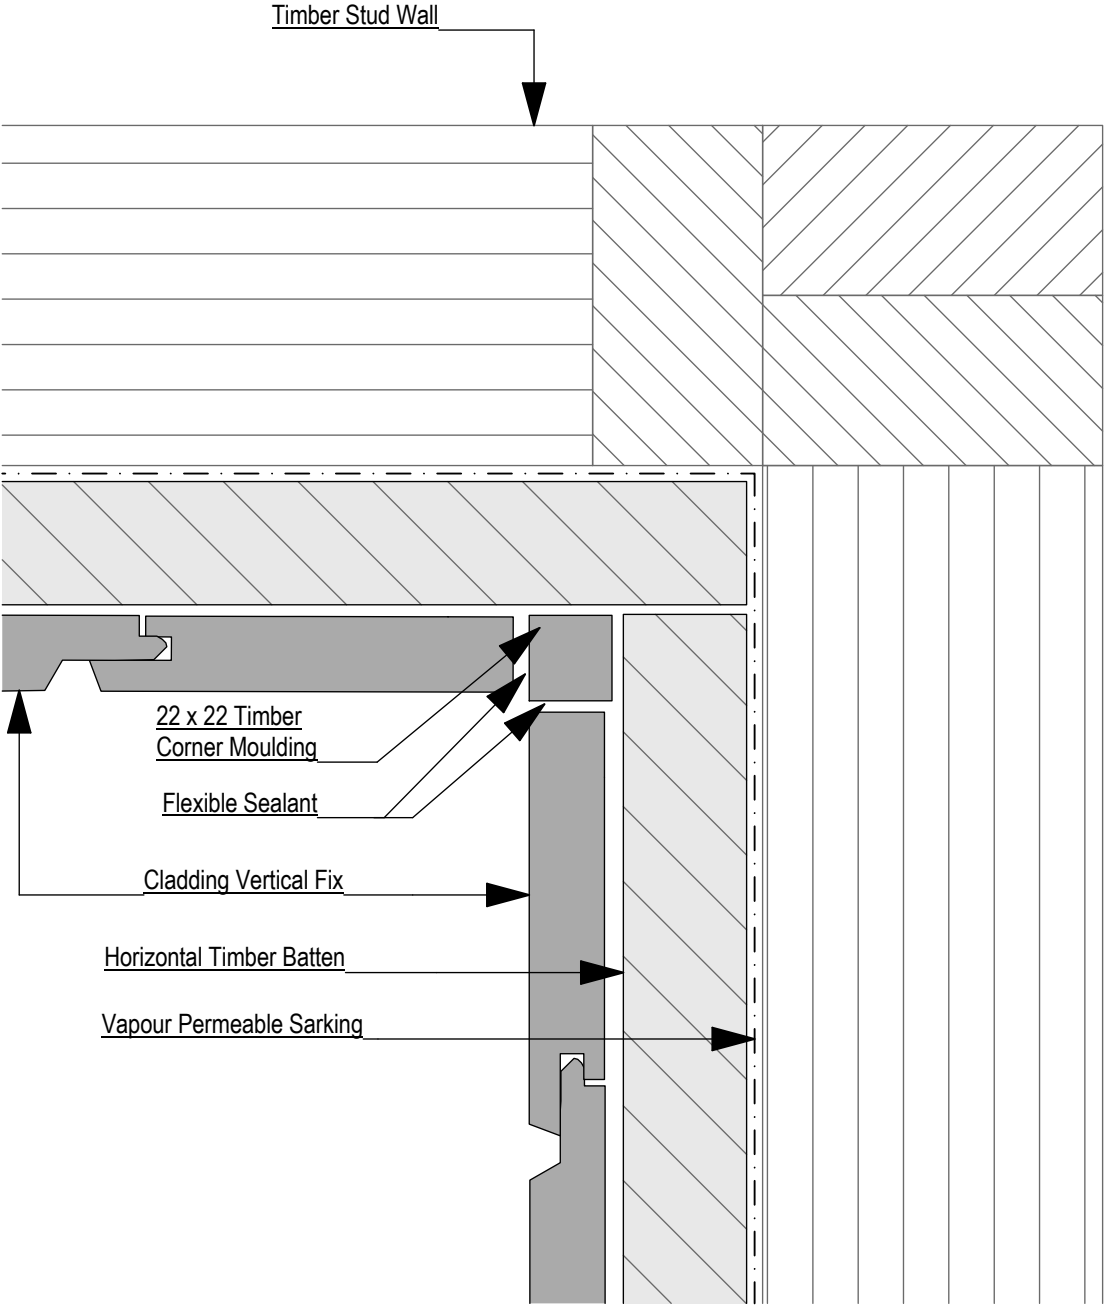
Dia 14: Vertical Fix to Timber Internal Corner - with Timber Profile- Top View

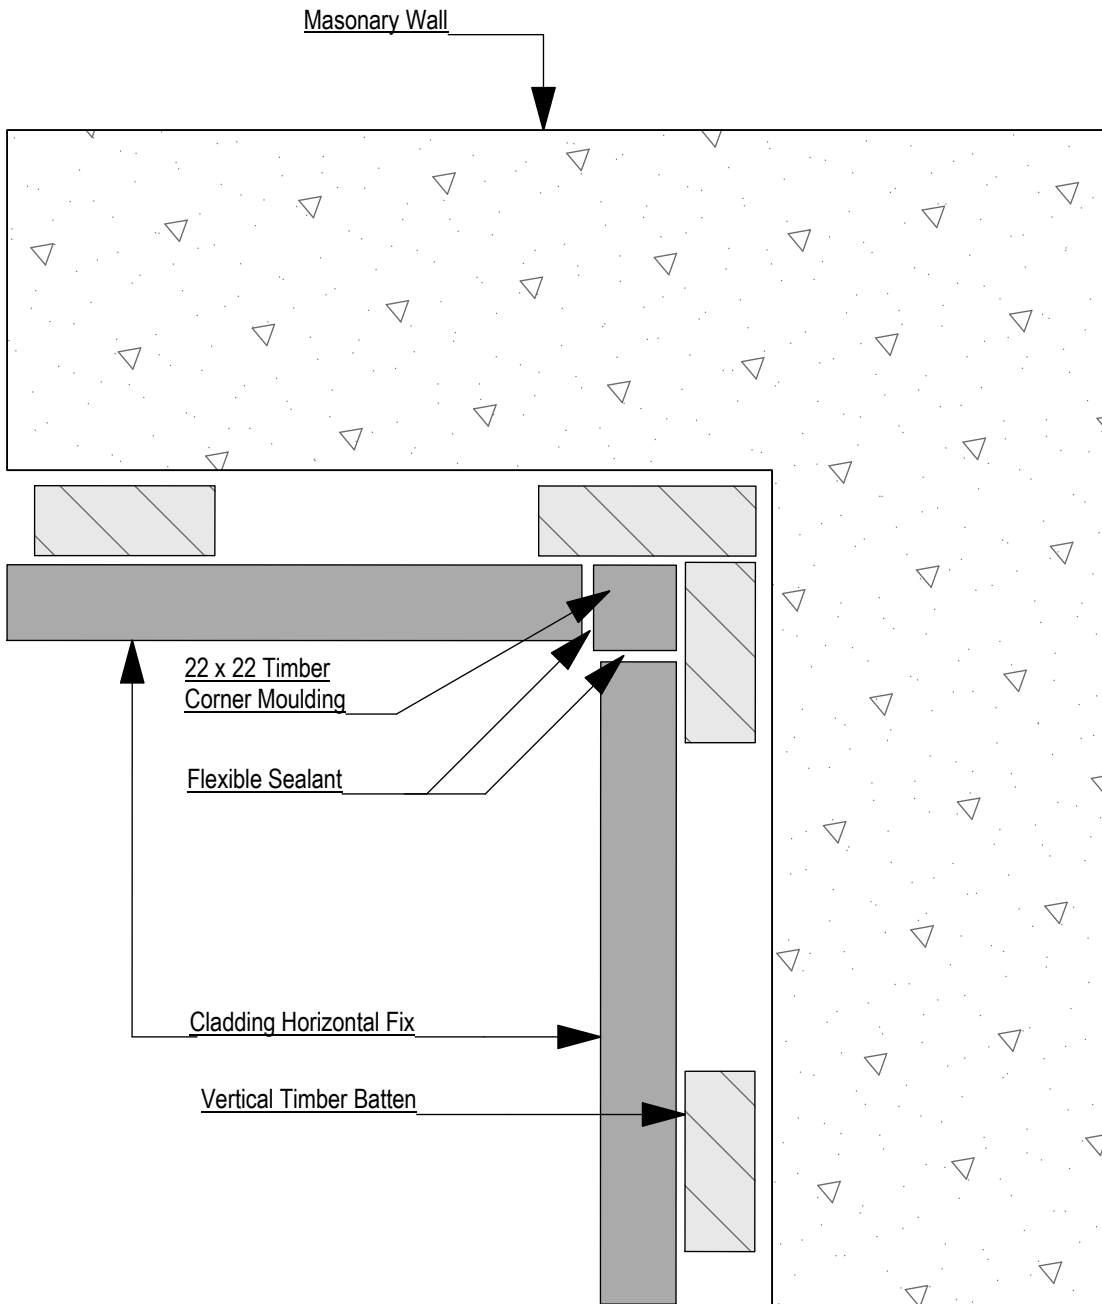
Dia 15: Horizontal Fix to Masonry Internal Corner - with Timber Profile- Top View
