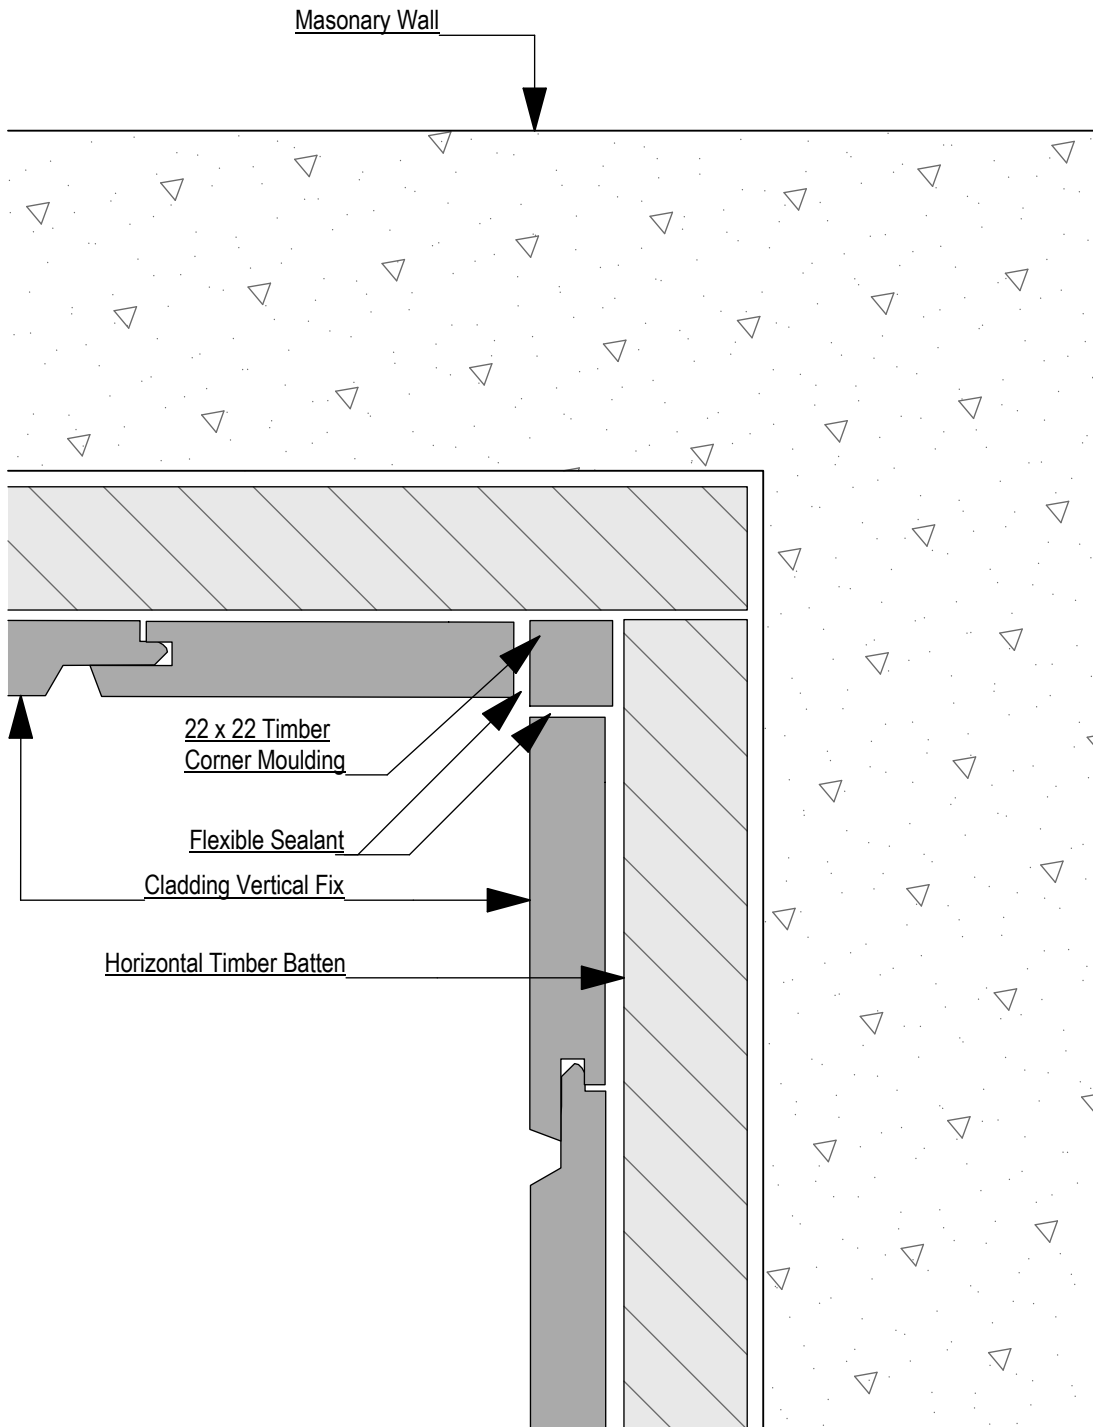
Dia 16: Vertical Fix to Masonry Internal Corner - with Timber Profile - Top View

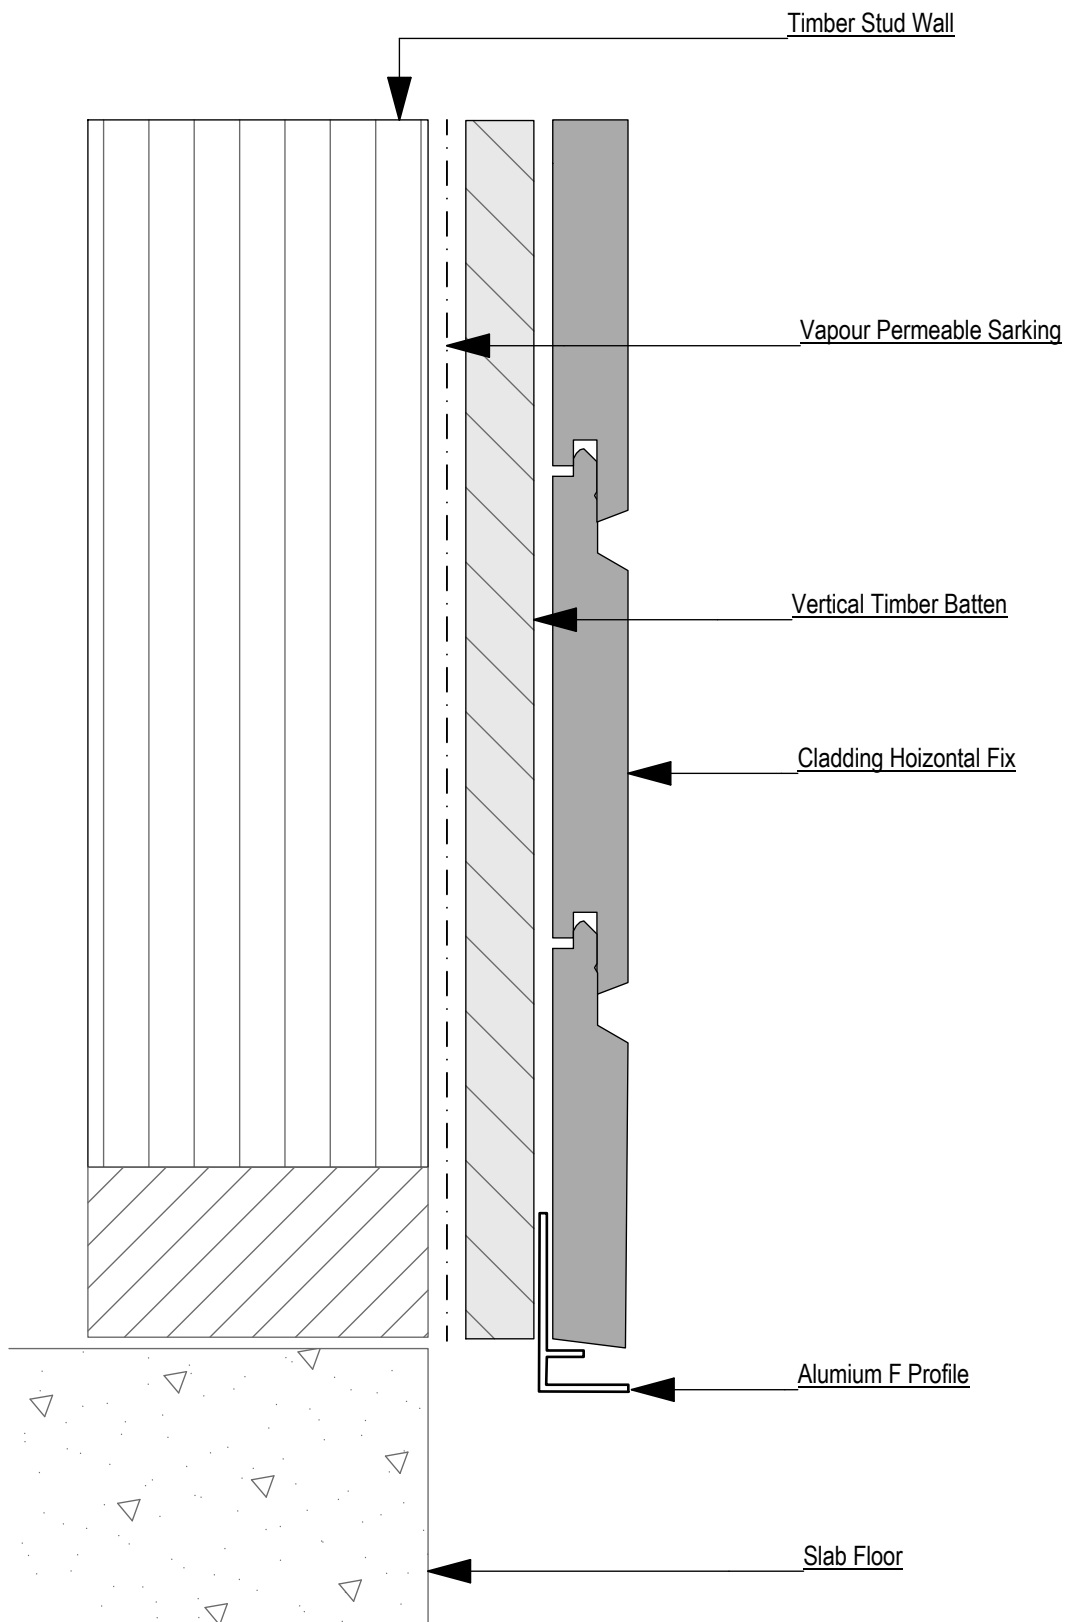
Dia 17: Horizontal Fix to Timber Wall - with Alumium F Profile - Base of Wall Side View

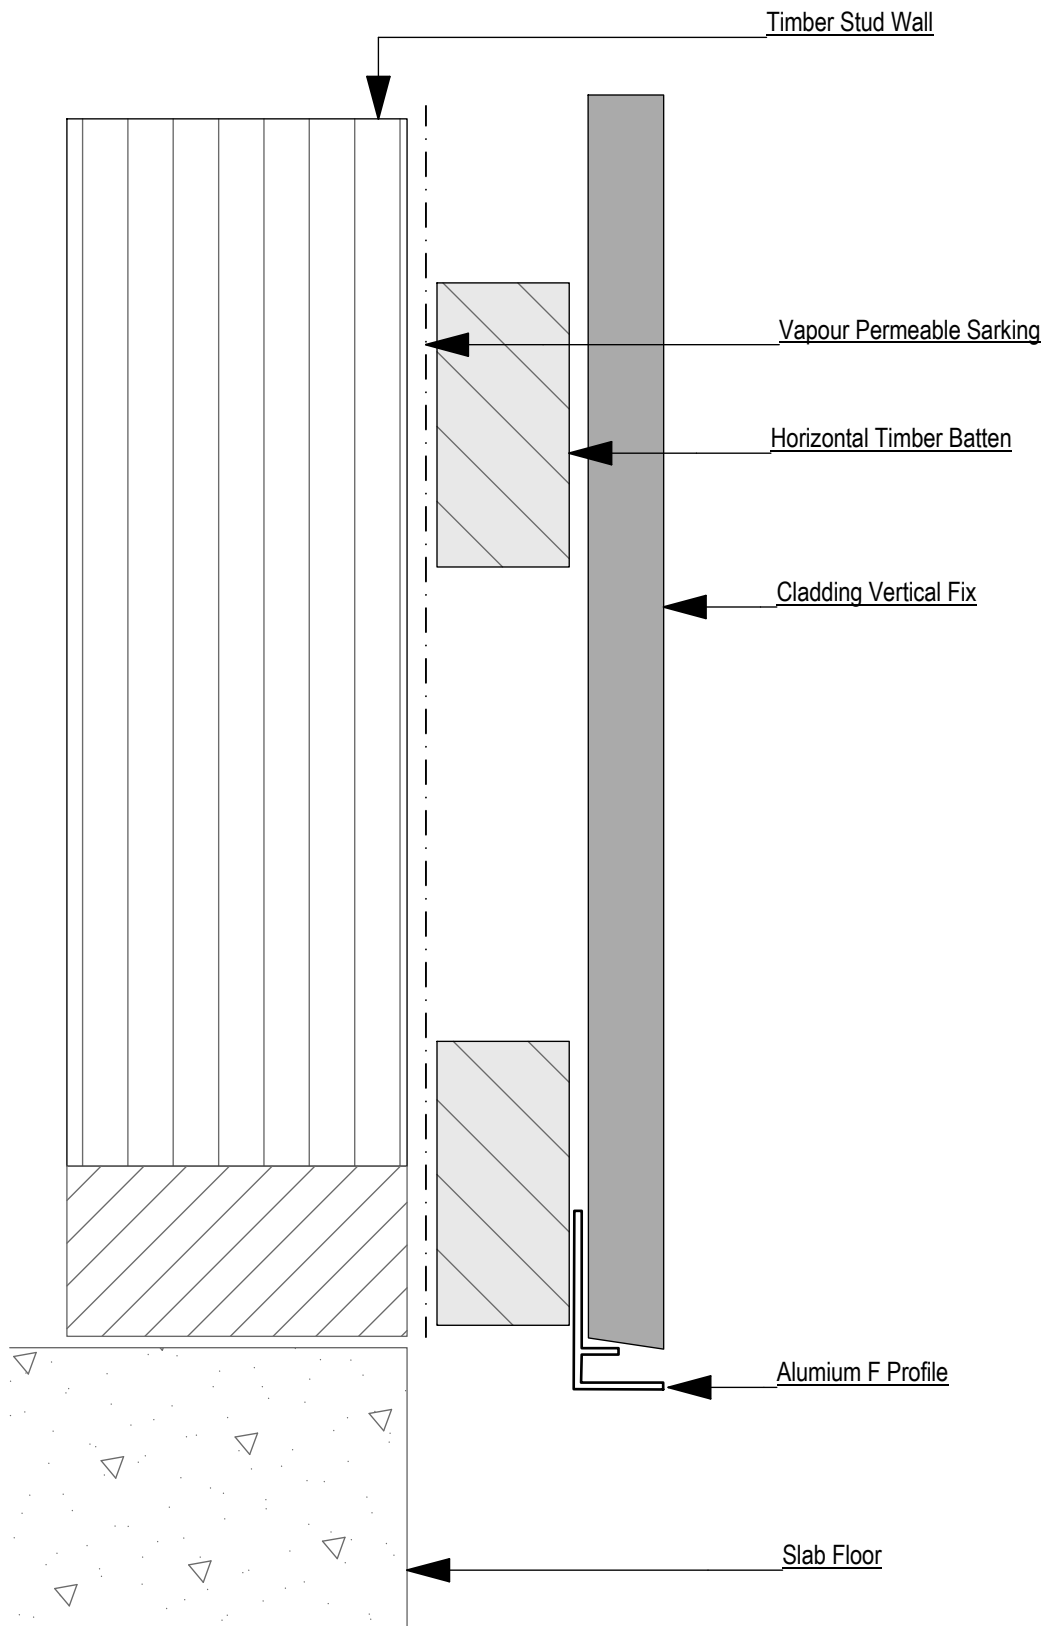
Dia 18: Vertical Fix to Timber Wall - with Alumium F Profile - Base of Wall Side View

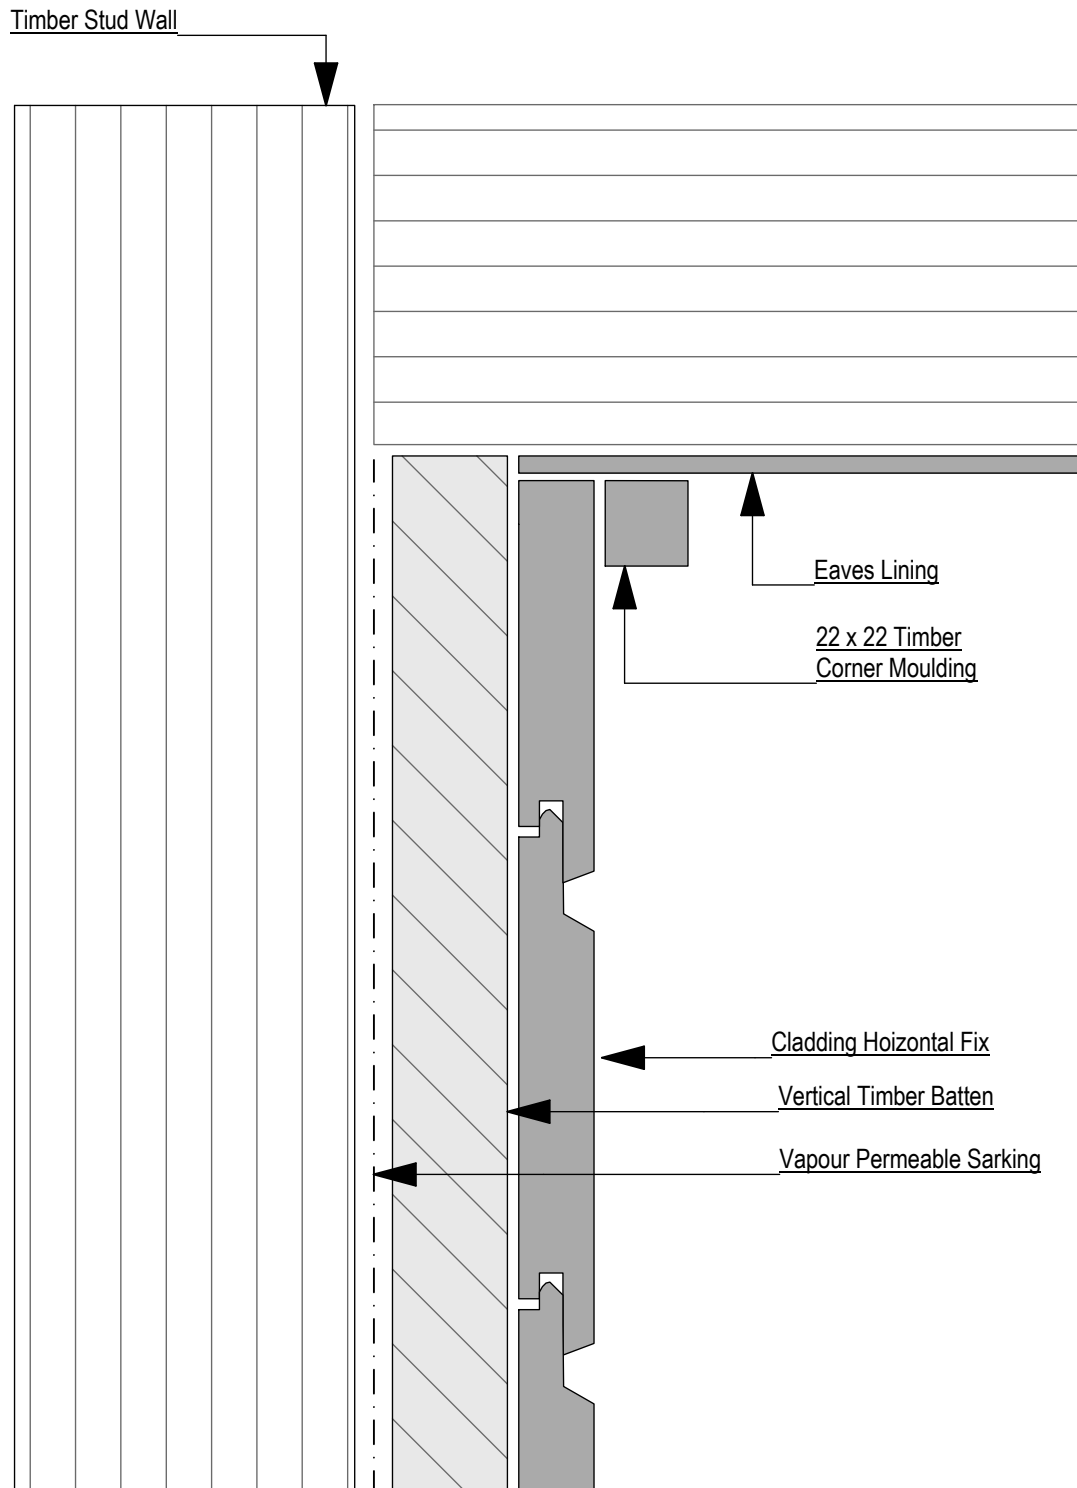
Dia 19: Horizontal Fix to Timber Wall - with Timber Profile - Ceiling Eaves Side View

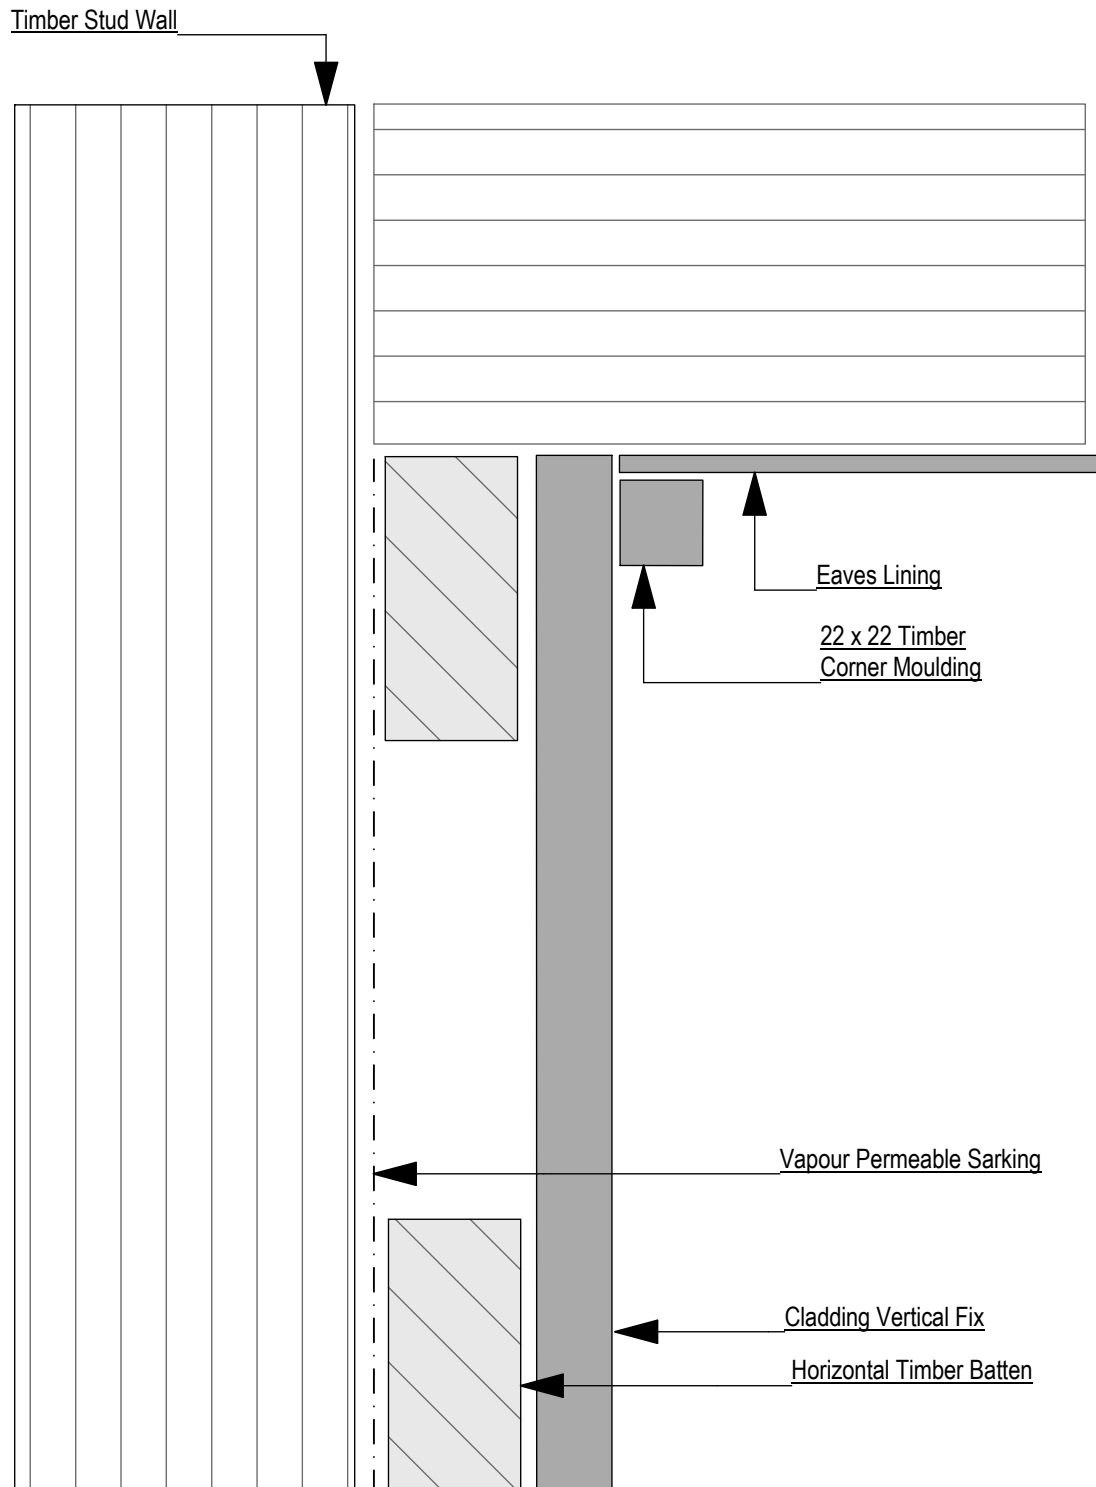
Dia 20: Vertical Fix to Timber Wall - with Timber Profile - Ceiling Eaves Side View

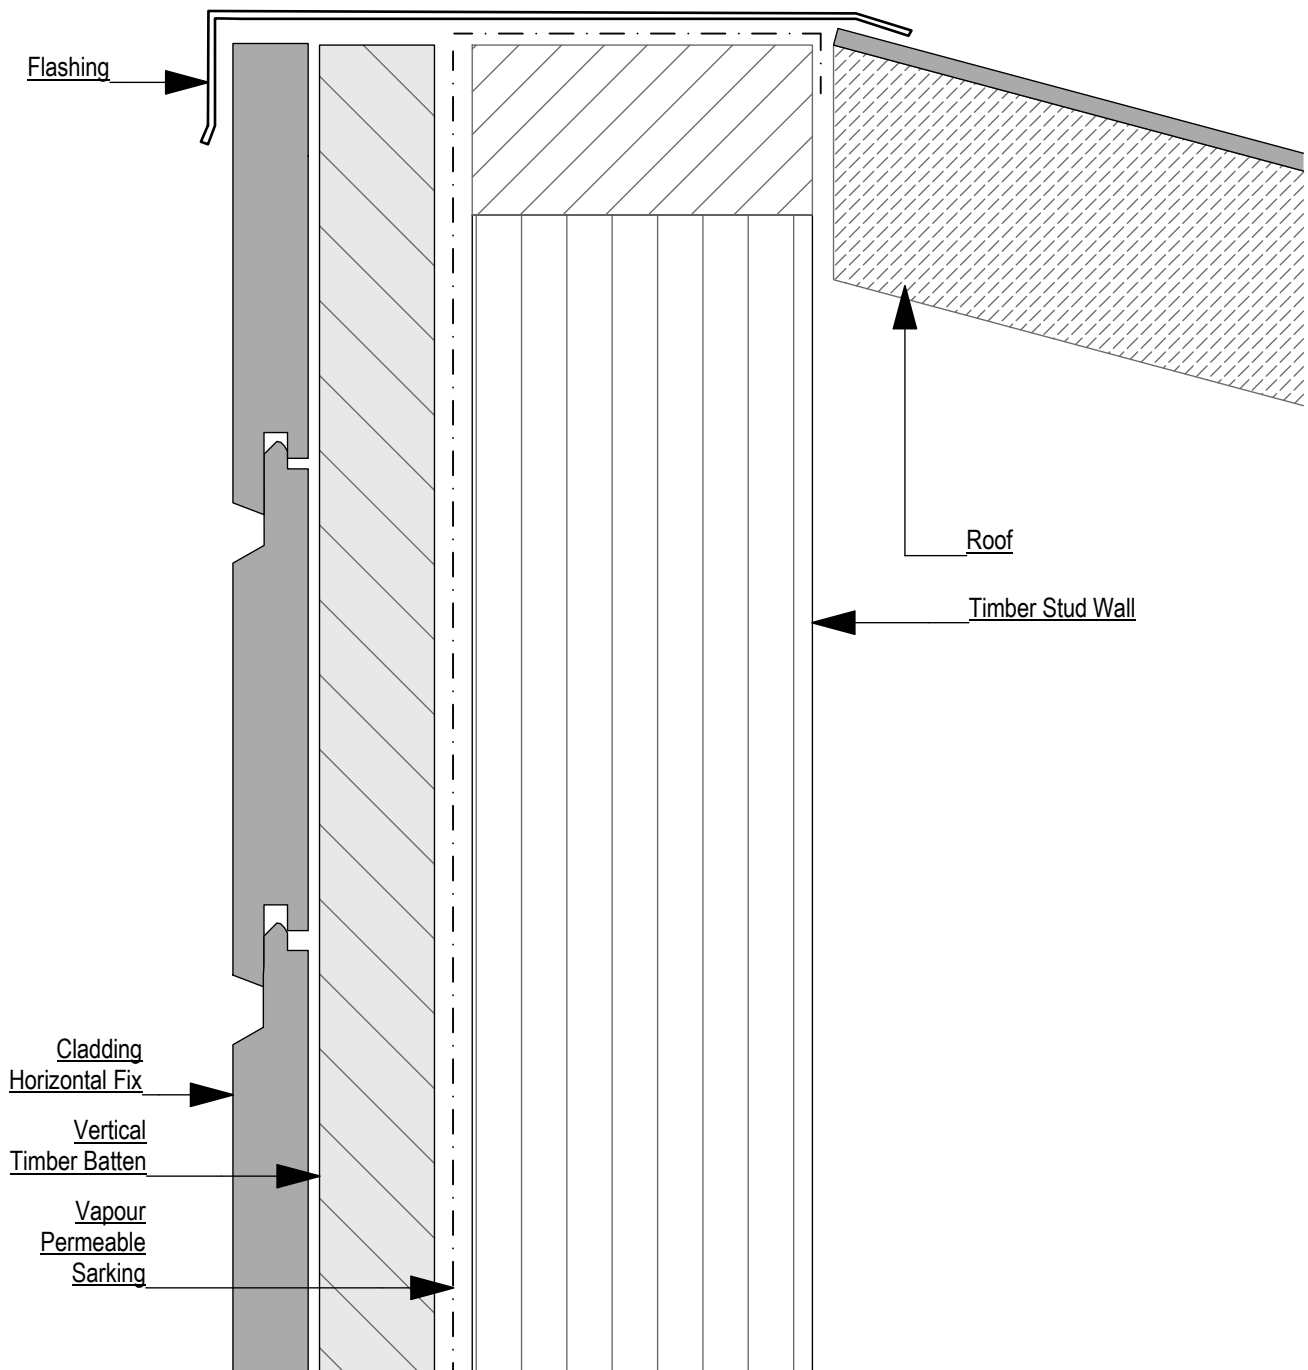
Dia 21: Horizontal Fix to Timber Wall Wall/Roof Detail - Side View

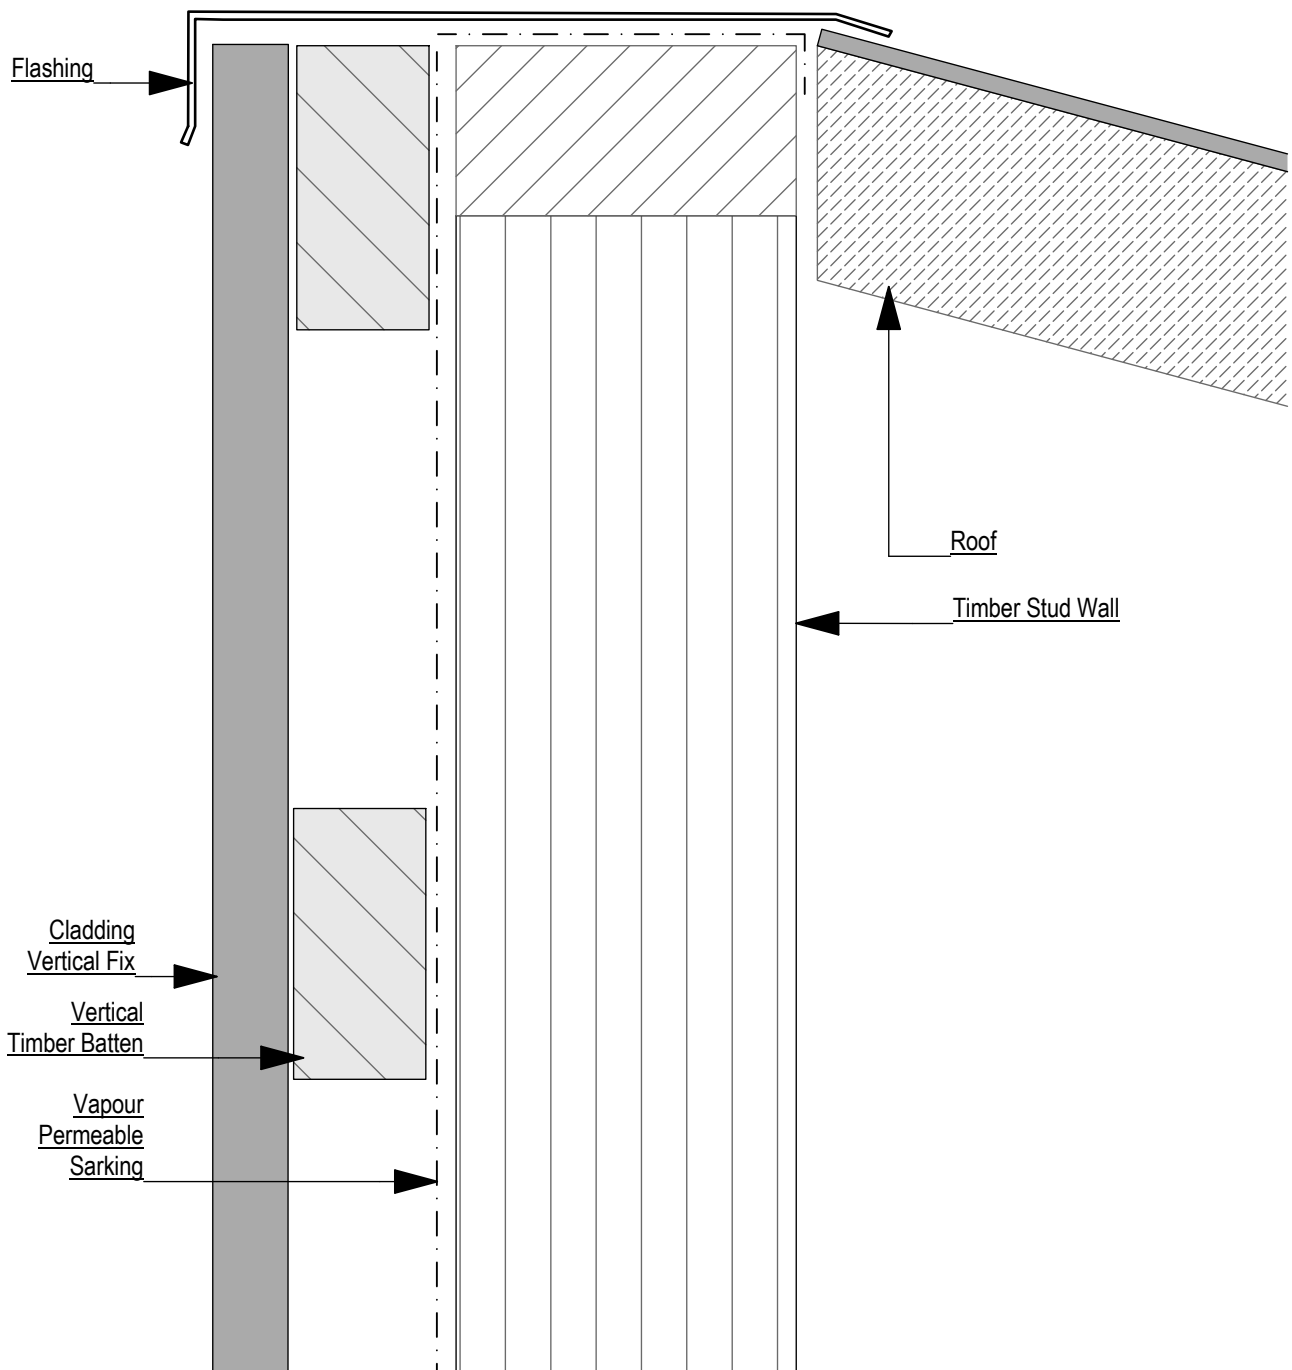
Dia 22: Vertical Fix to Timber Wall Wall/Roof Detail - Side View

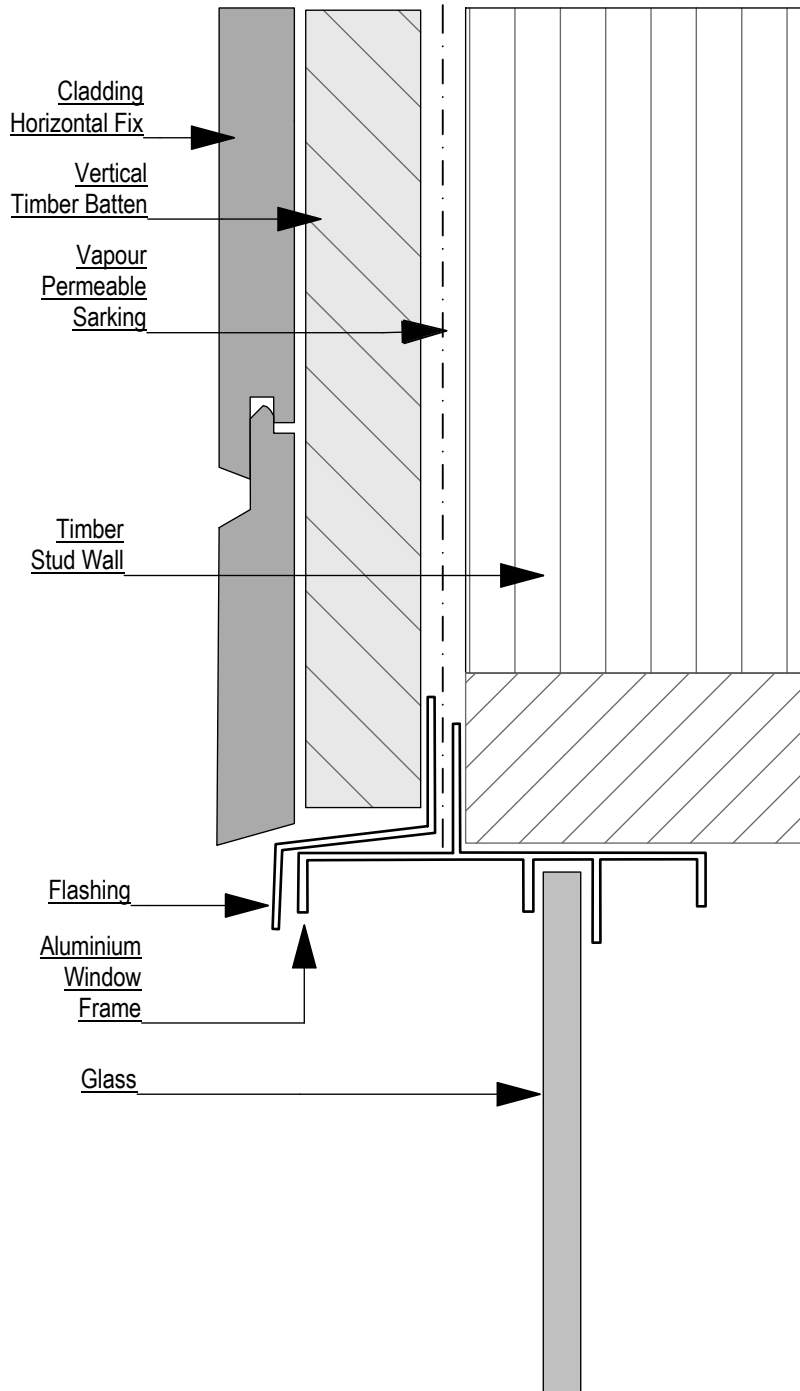
Dia 23: Horizontal Fix to Timber Wall Window Head Detail - Side View

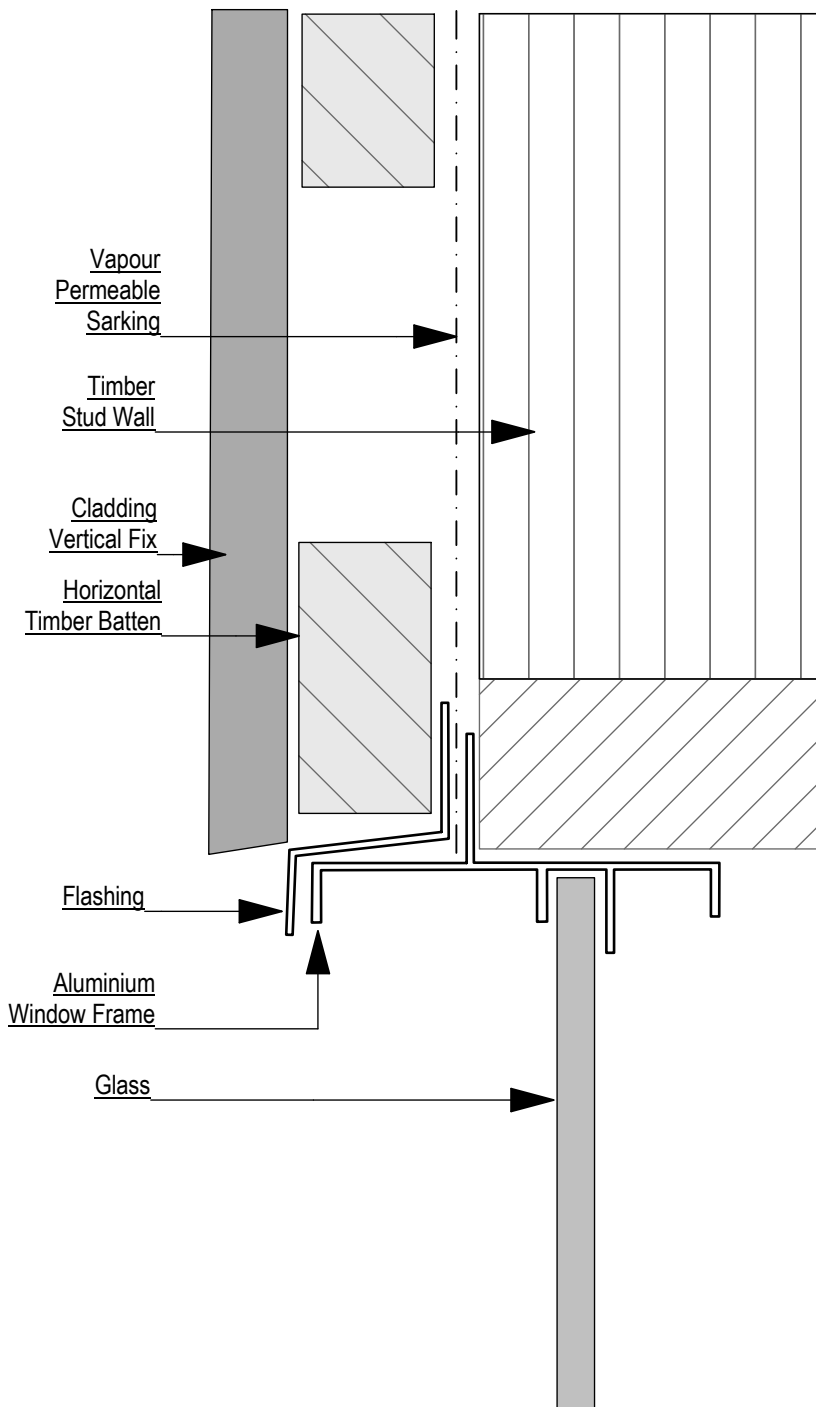
Dia 24: Vertical Fix to Timber Wall Window Head Detail - Side View

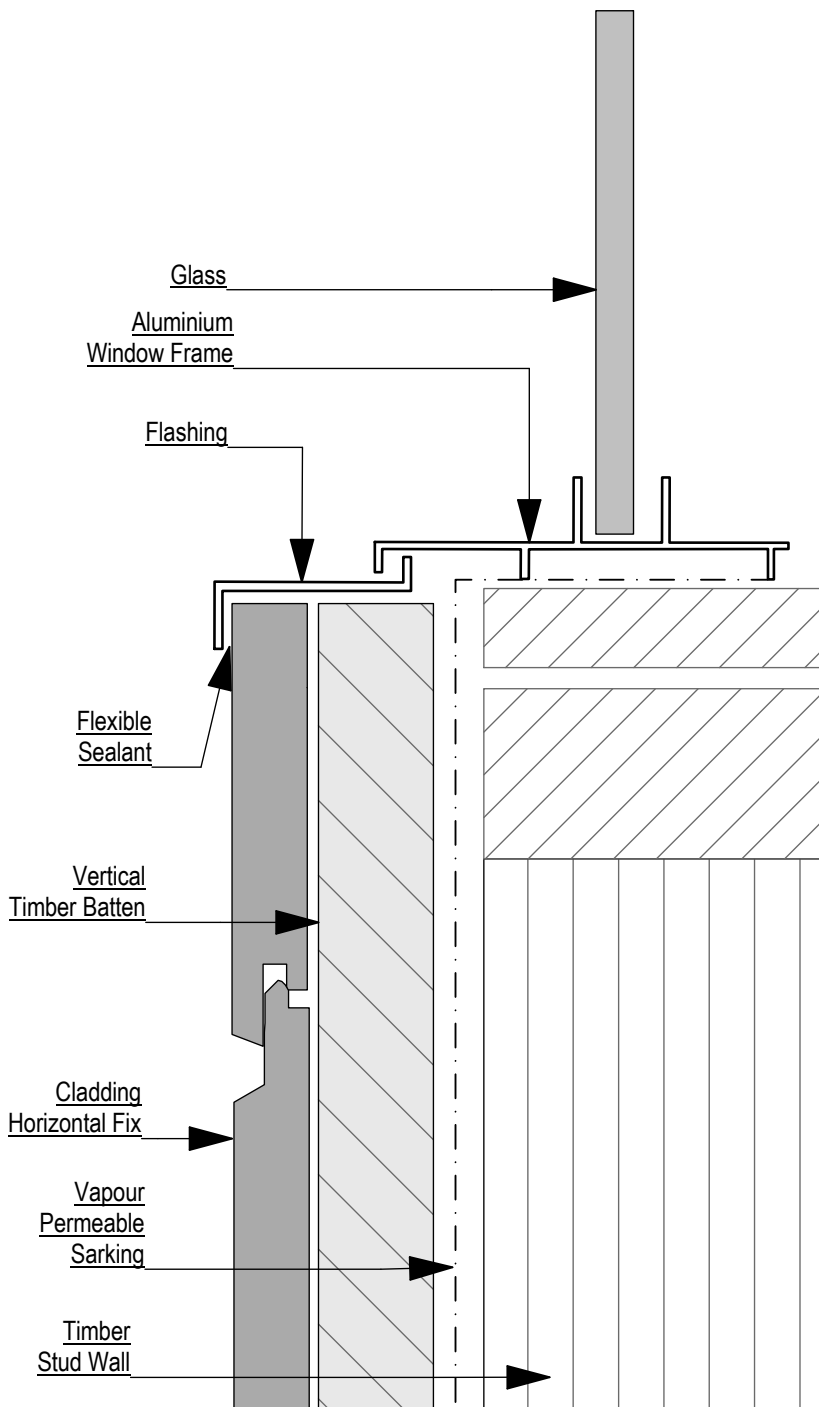
Dia 25: Horizontal Fix to Timber Wall Window Sill Detail - Side View

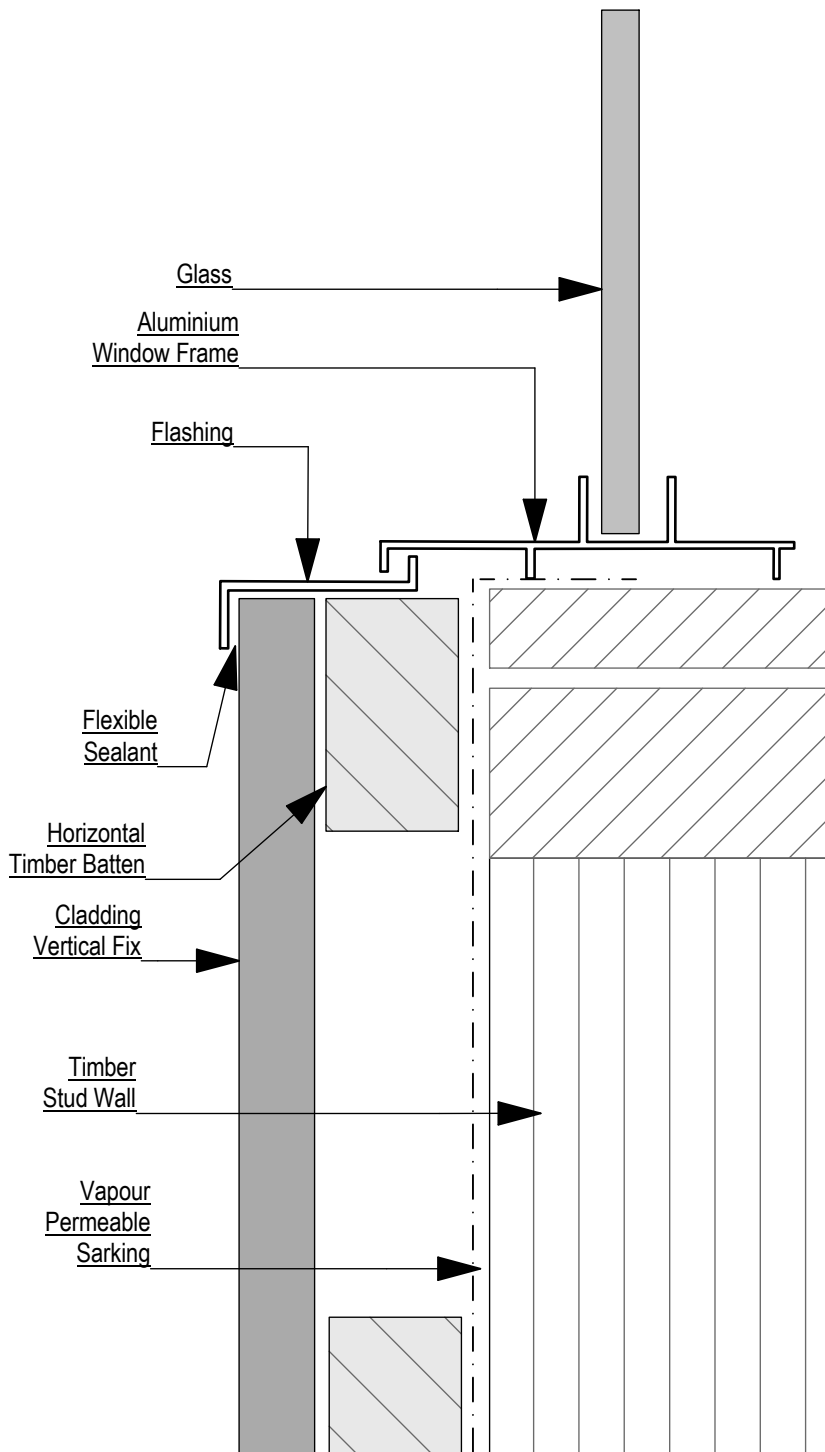
Dia 26: Vertical Fix to Timber Wall Window Sill Detail - Side View

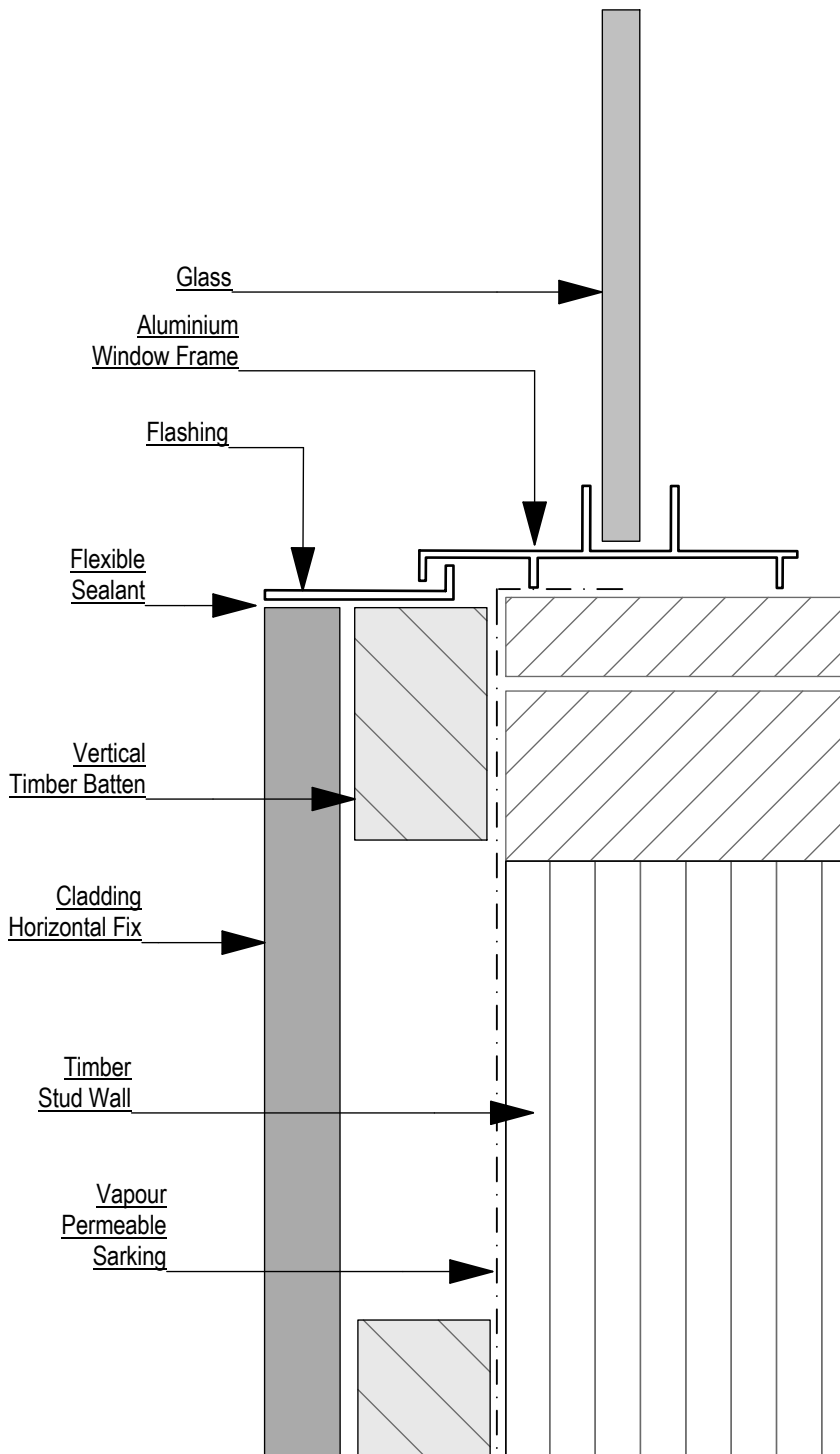
Dia 27: Horizontal Fix to Timber Wall Window Jamb Detail - Top View

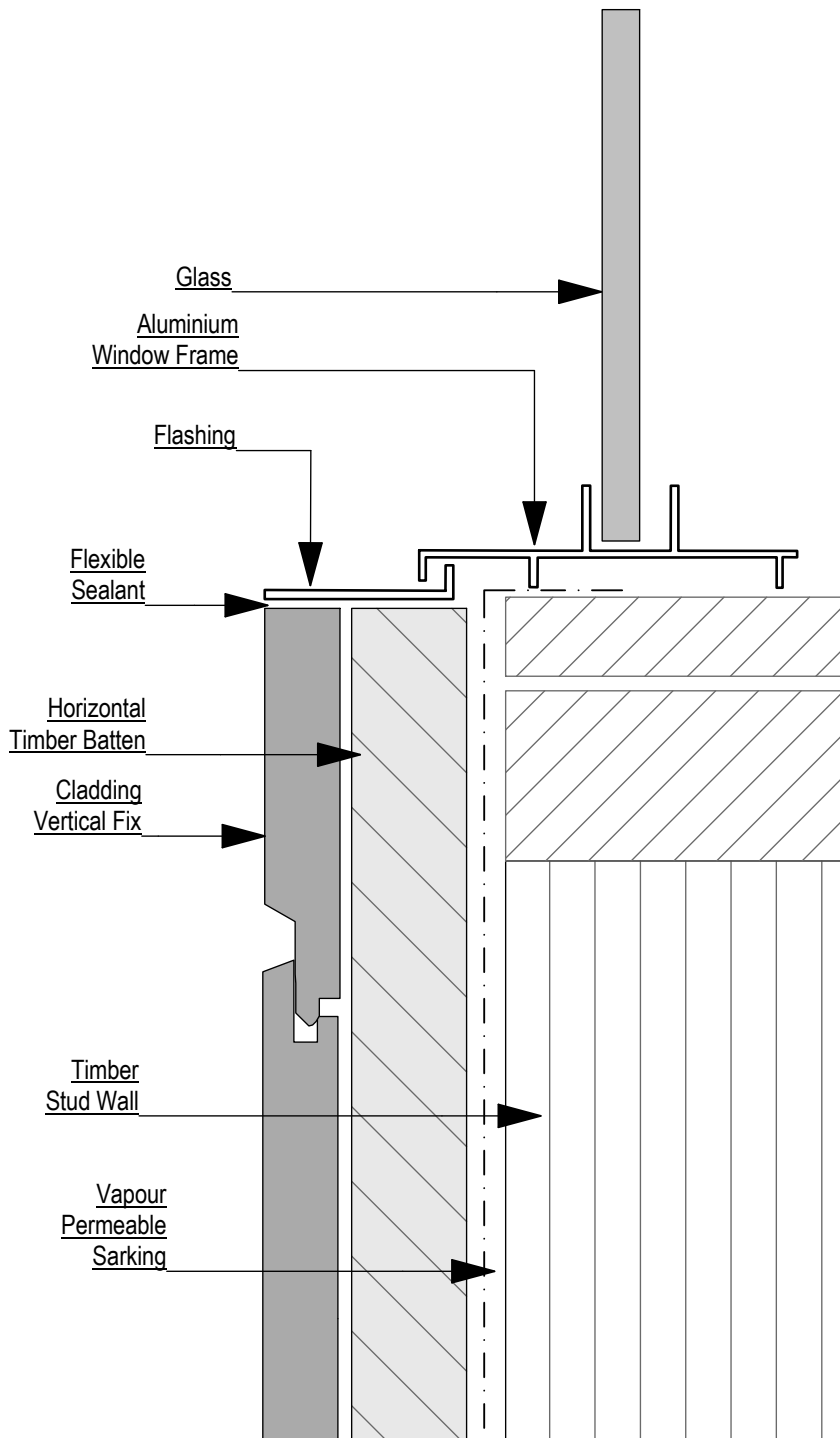
Dia 28: Vertical Fix to Timber Wall Window Jamb Detail - Top View

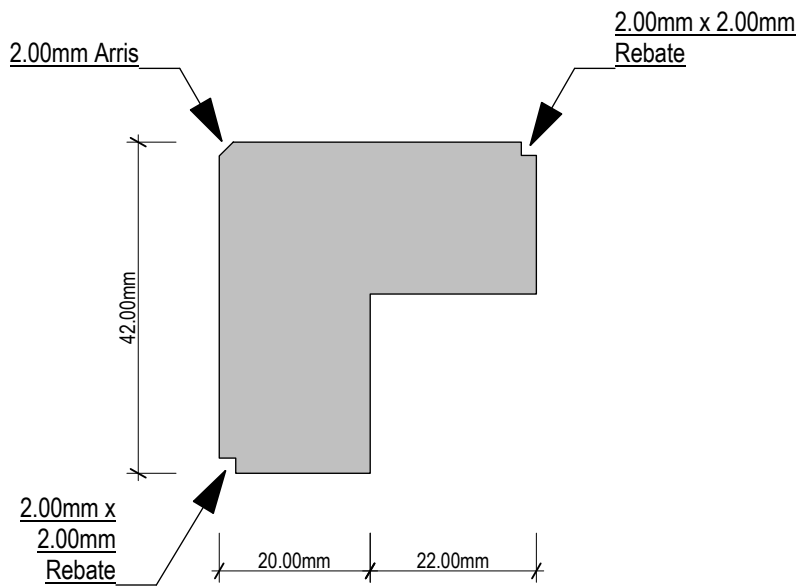
Dia 30: External Timber Profile
